Washoe Tribe of Nevada and California
2023 Leviathan Mine Superfund Site Tour

History

3 Treatment Processes

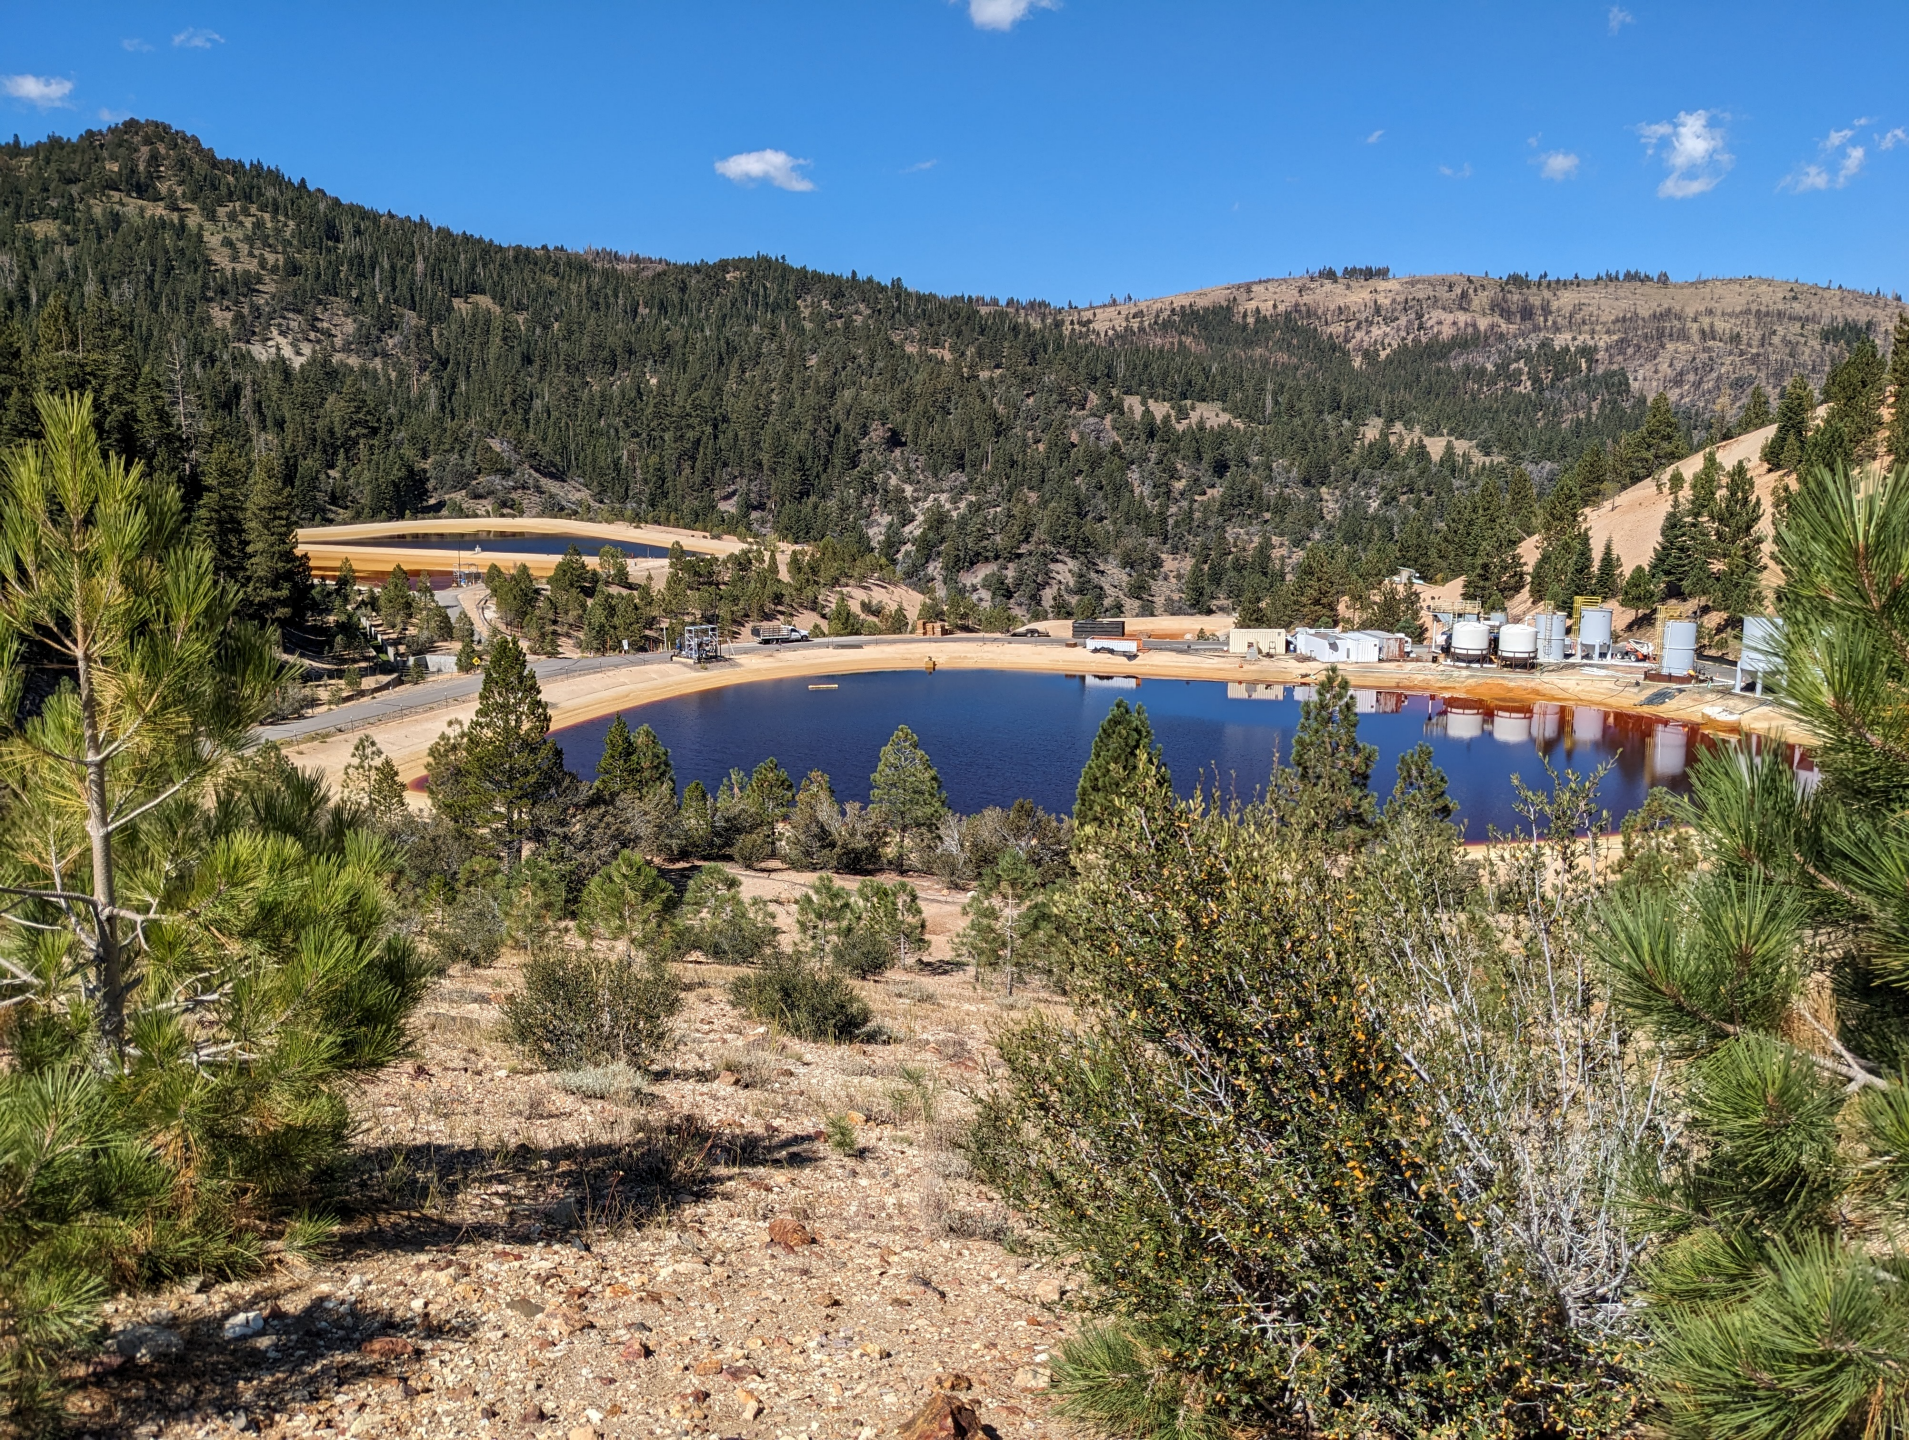
Stop 1: Upper Ponds and Treatment Area Overlook

Ponds in the southern part of the site are part of the pond water treatment system treating the water with lime to reduce acidity and settle out heavy metals.

Up in the top right you can see the Tamarack Fire scar. Revegetation efforts at the site had to be balanced with the growing threat of wildfire.

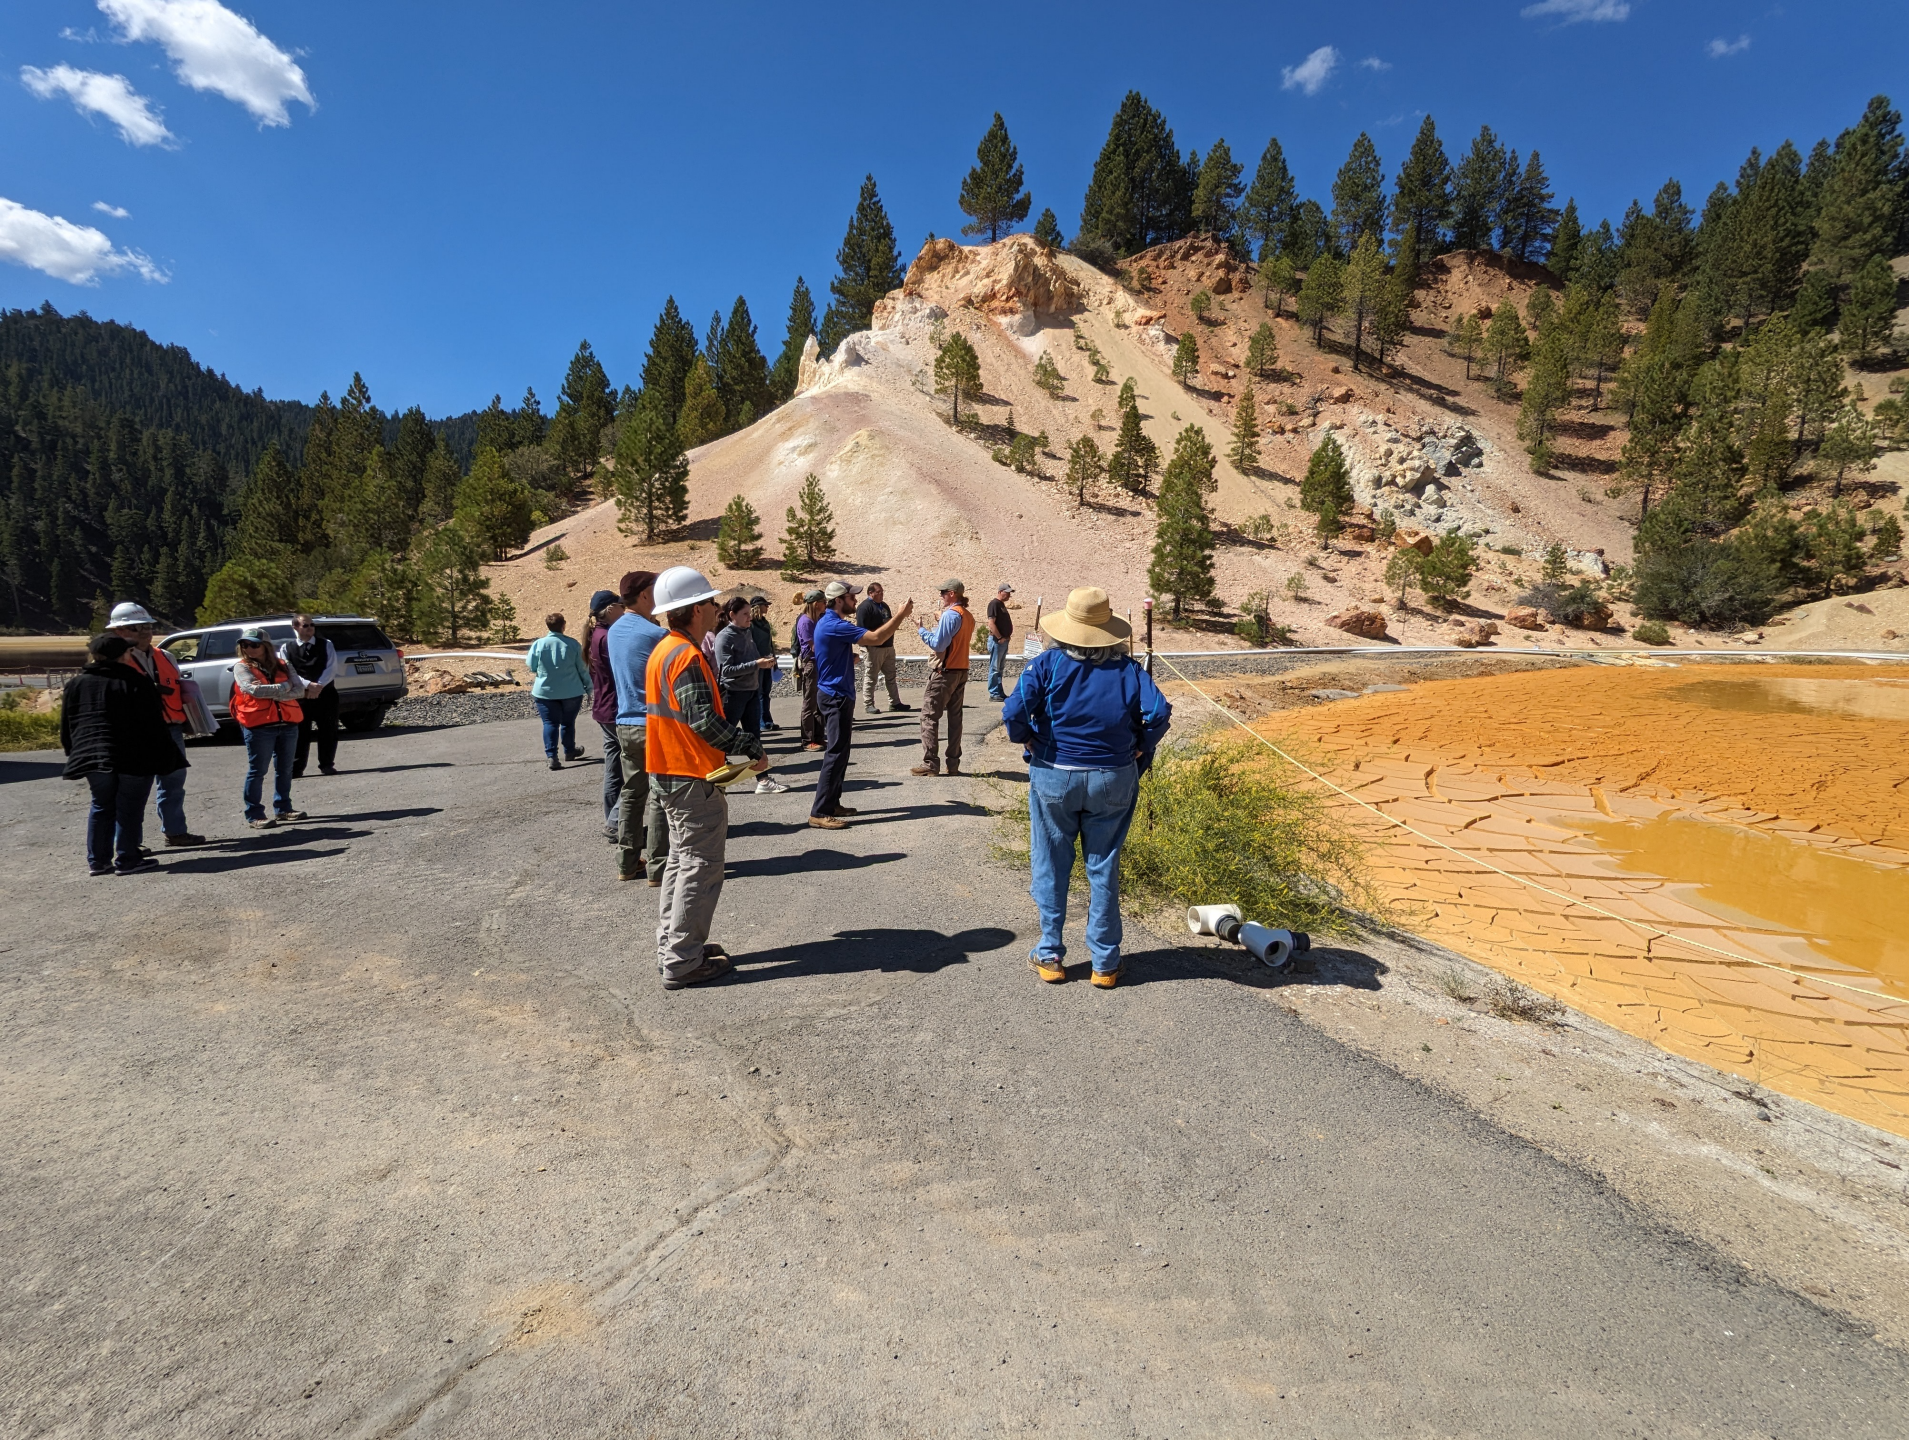
Stop 2: Pit and Pit Clarifier

After the water is treated, the clean water is routed to Leviathan Creek while the remaining heavy metals that were mentioned on the previous slide become sludge. This sludge is pumped into an evaporation pond. As the sludge dries it becomes lighter and reduces in volume. Dry sludge is cheaper to contain and then transport off site.

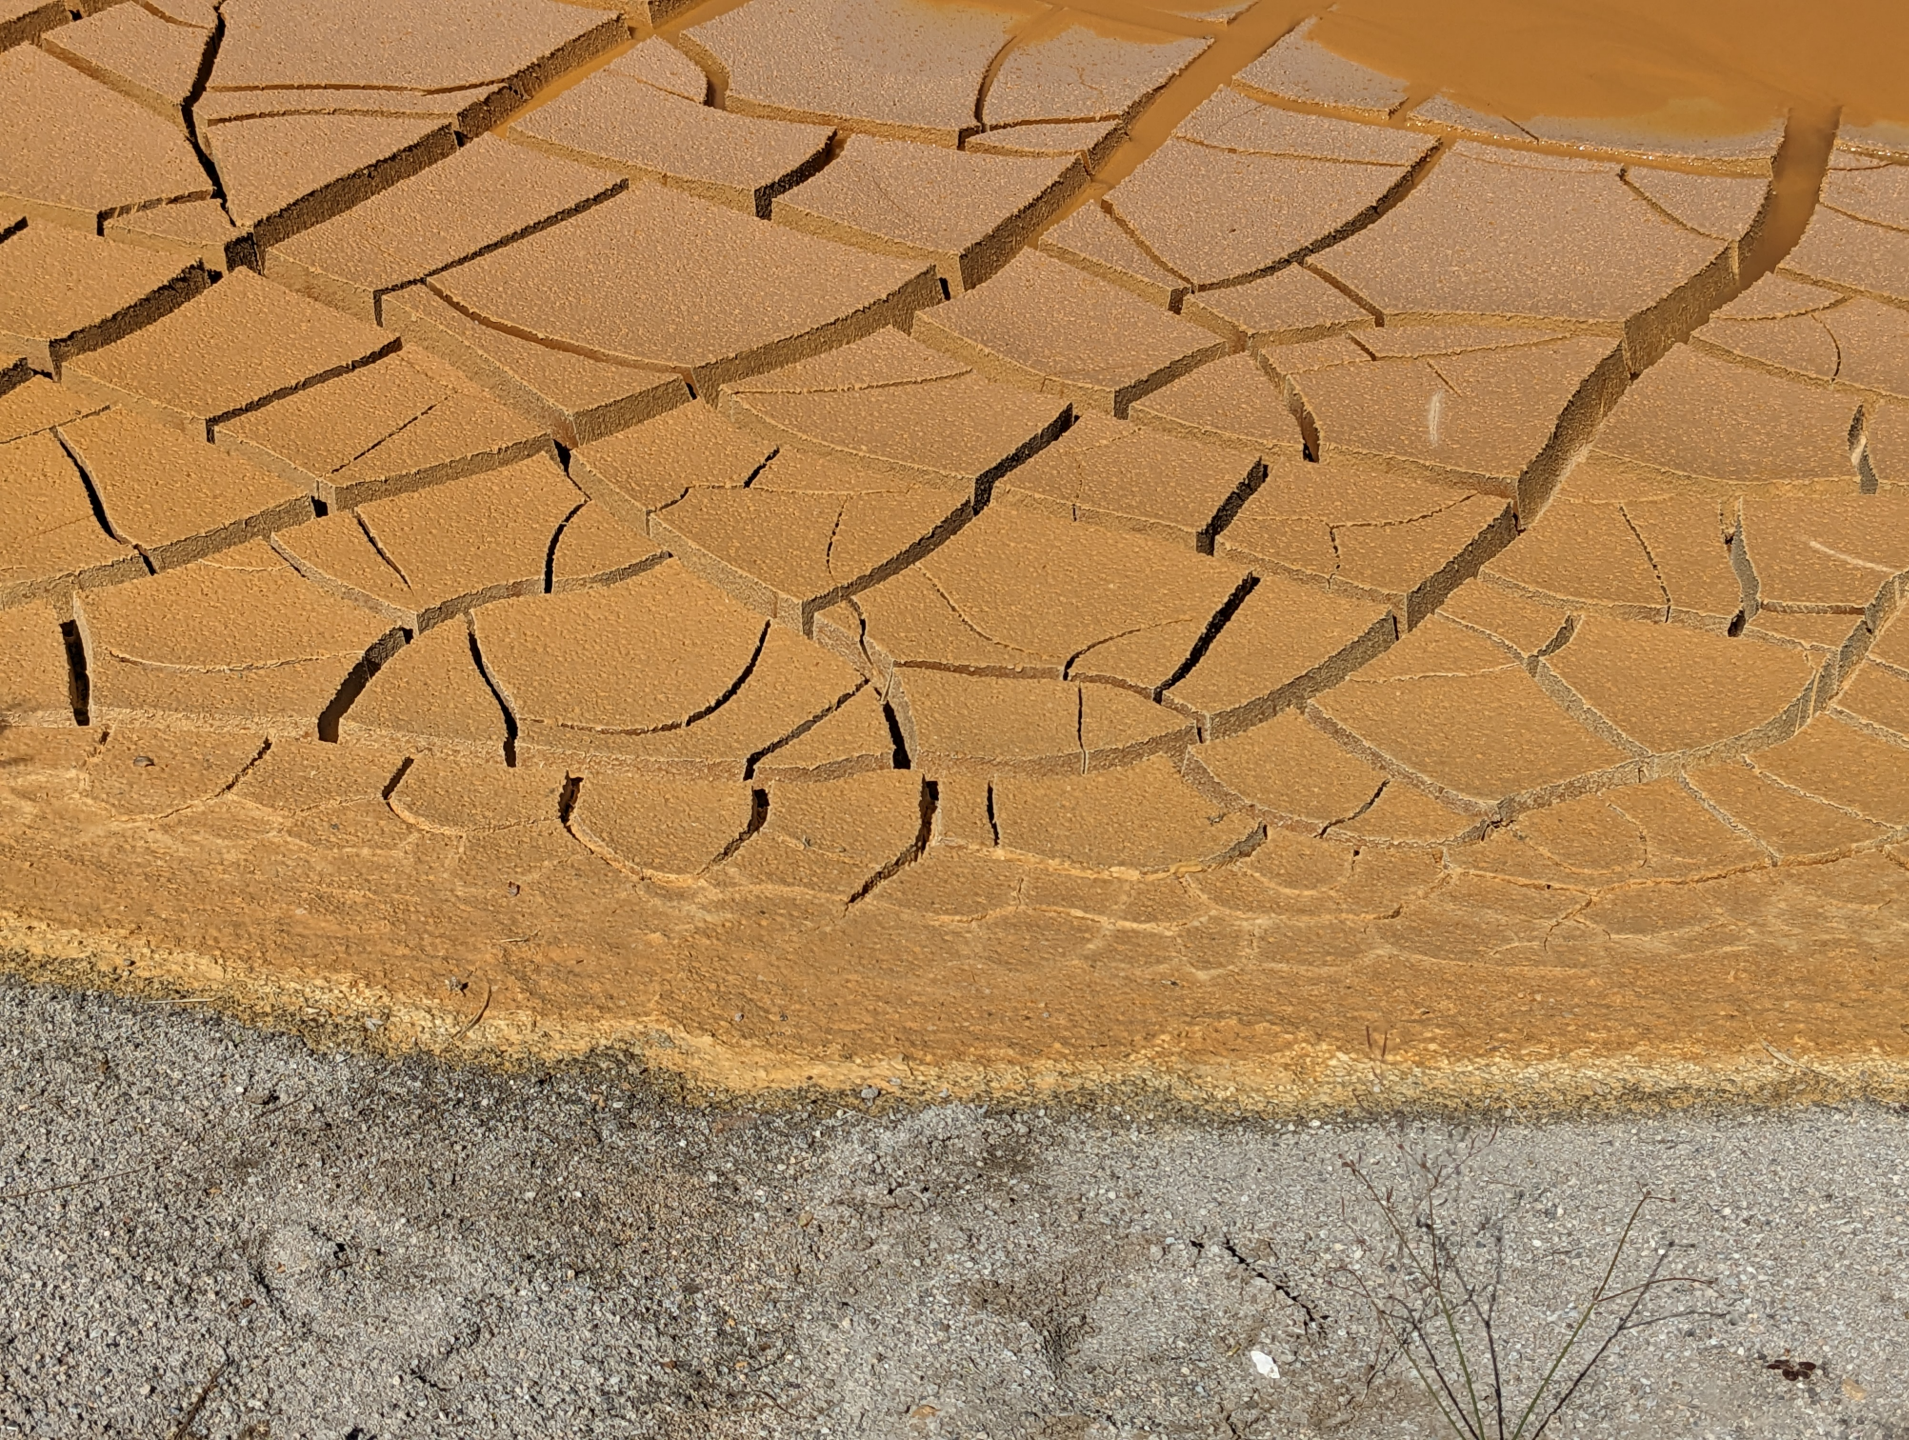
Each year sludge from the previous treatment season is excavated from the pit clarifier and hauled offsite for disposal in a hazardous waste landfill.

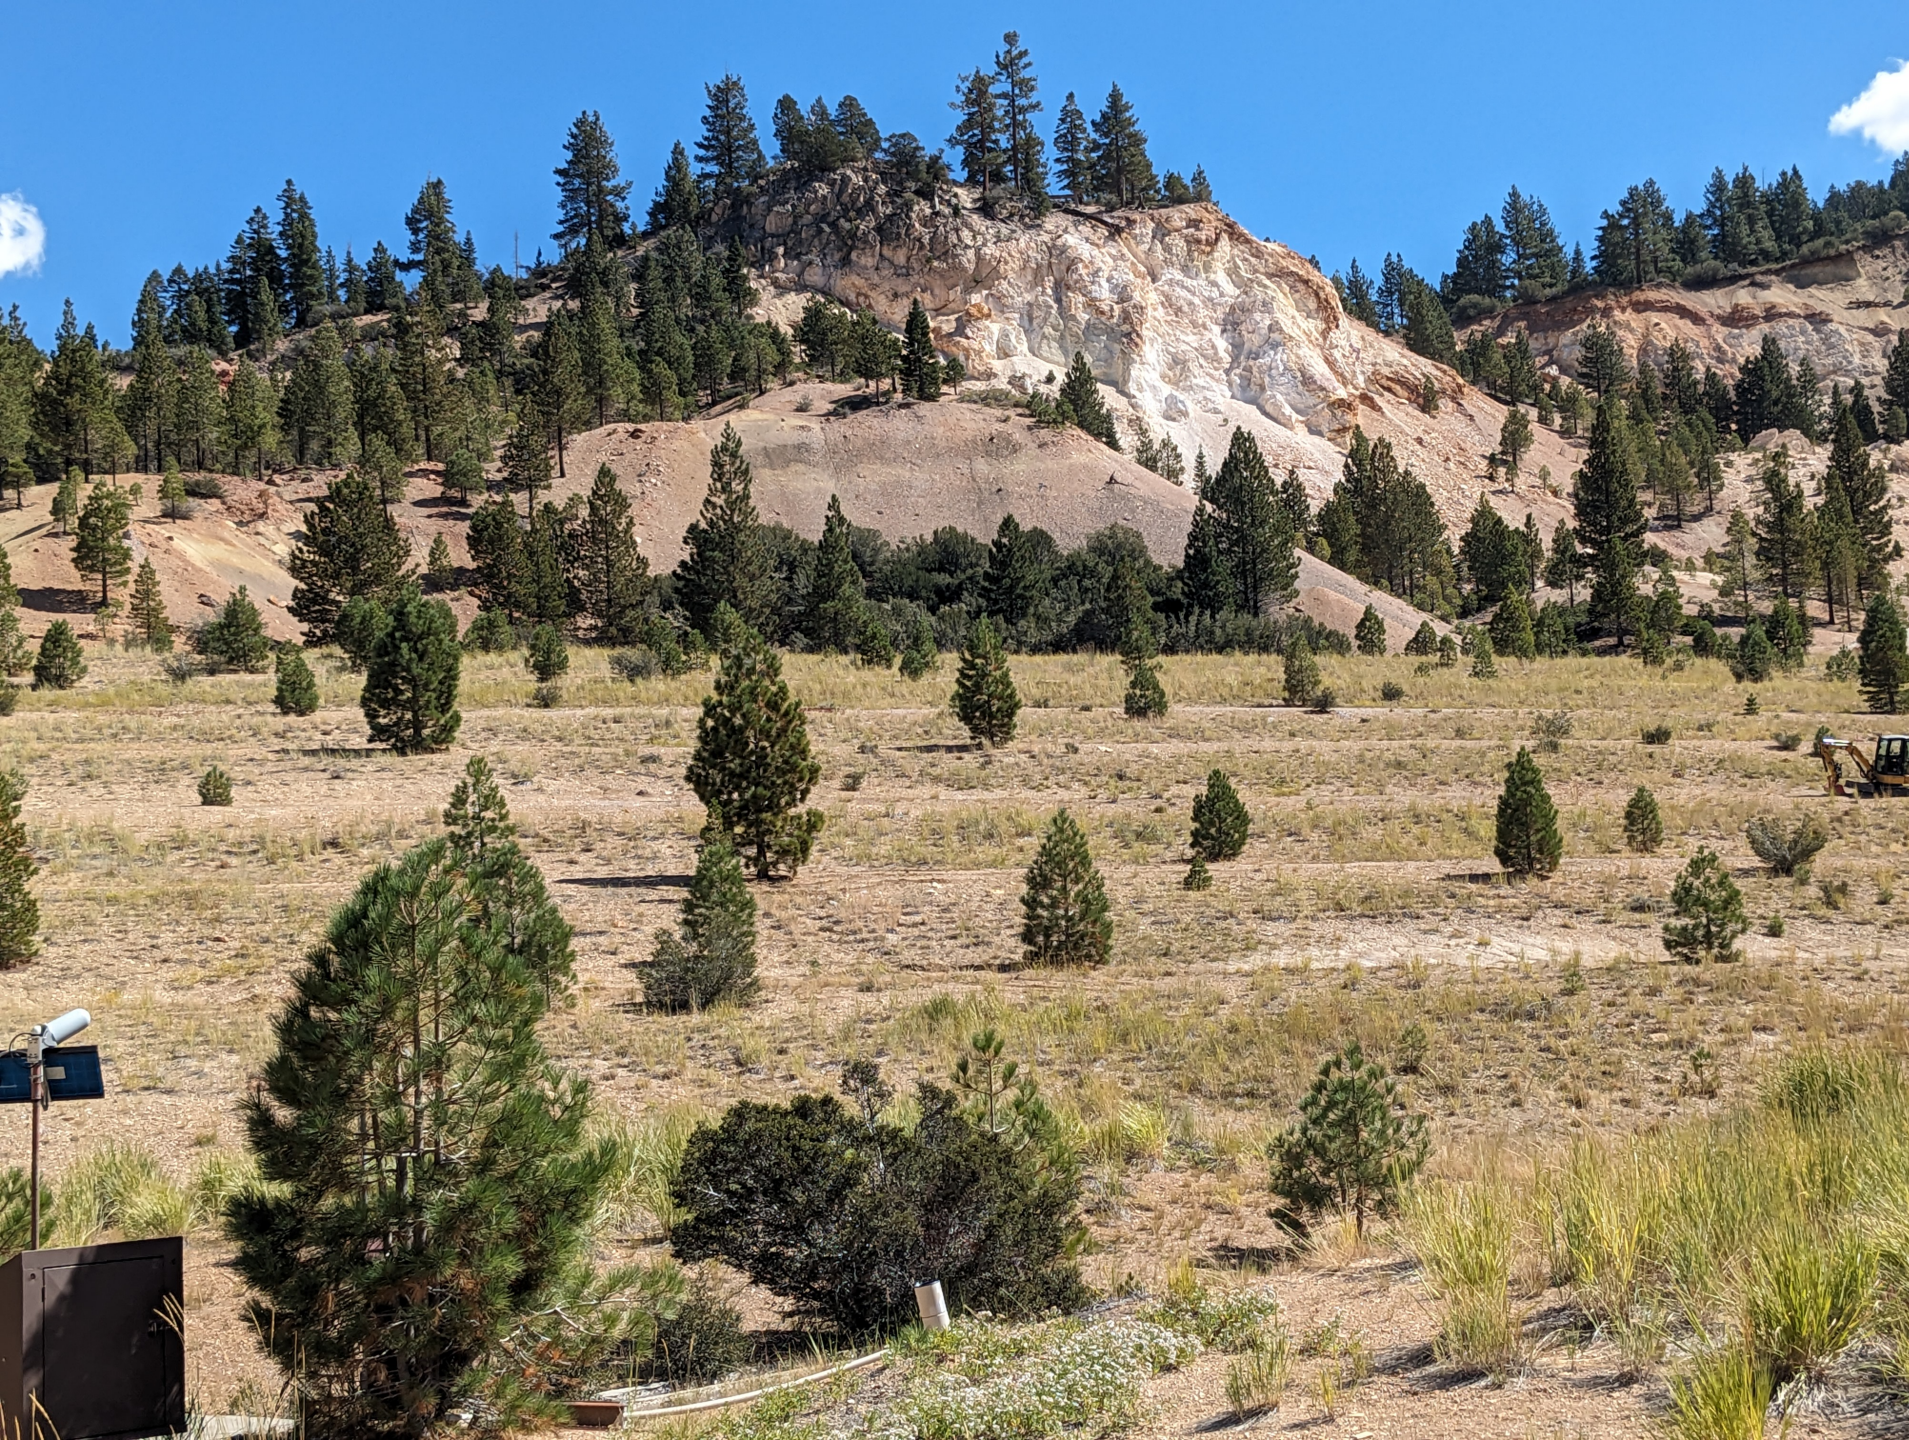
Next to the pit clarifier is the site of the open pit mine site. A 350-foot-tall peak was mined from this spot - that's the equivalent of a 32-story building.

You can see the revegetation efforts. While they only planted native species, non-native species have been introduced to the area from trucks. They now have a process to clean trucks before they arrive on site.

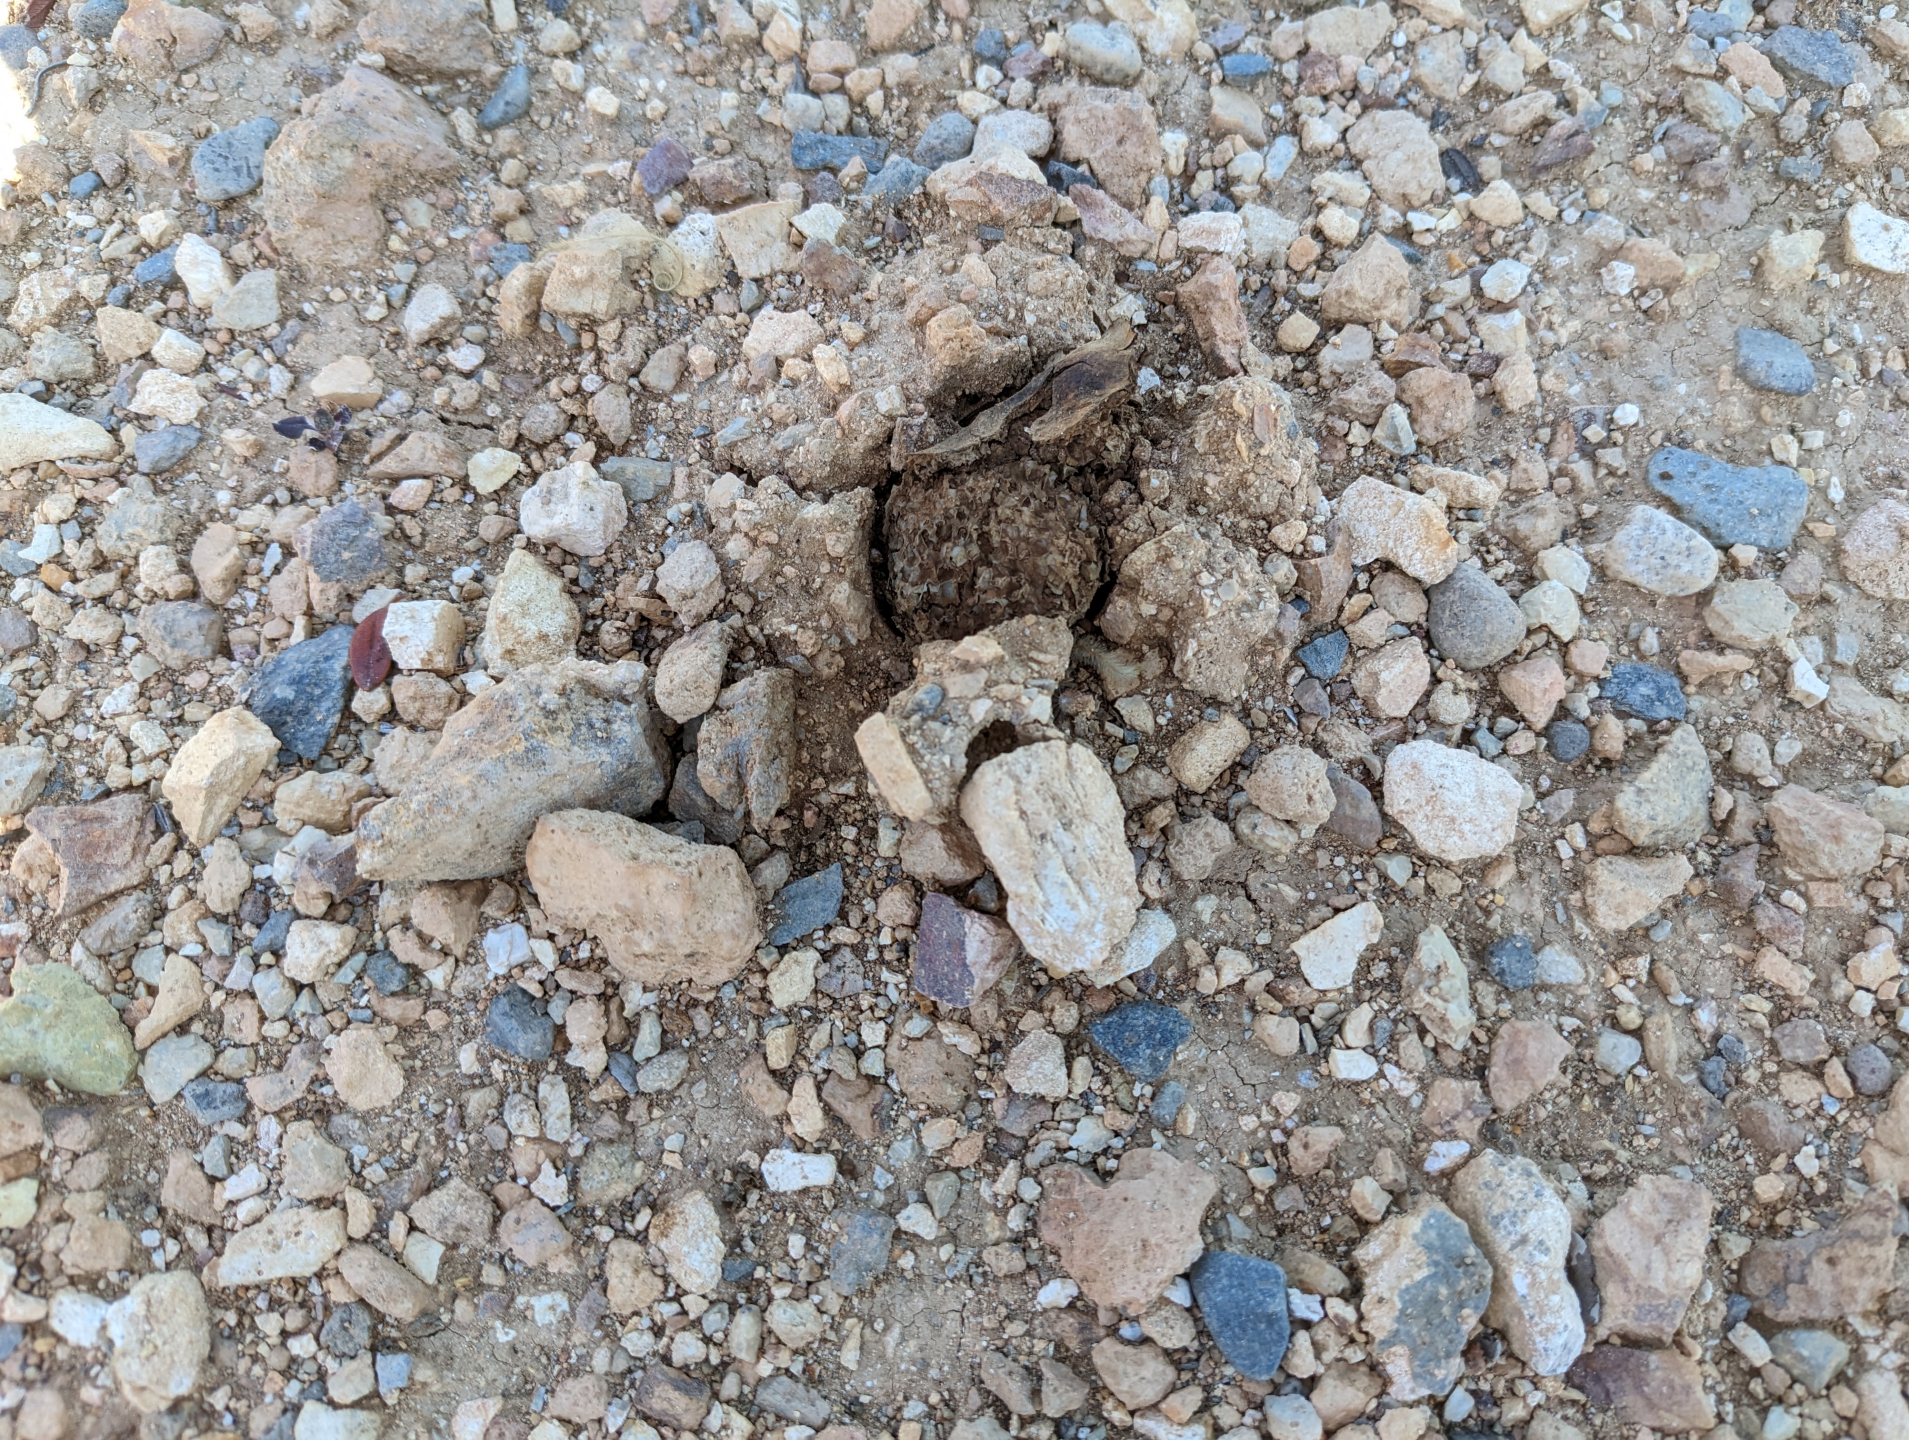
This doesn't look like much, but this is mycorrhizae. As part of the revegetation effort, the roots of new plants were treated with mycorrhizae to help them flourish. This volunteer brown 'puff' shows that the mycorrhizae is helping to establish an underground network.

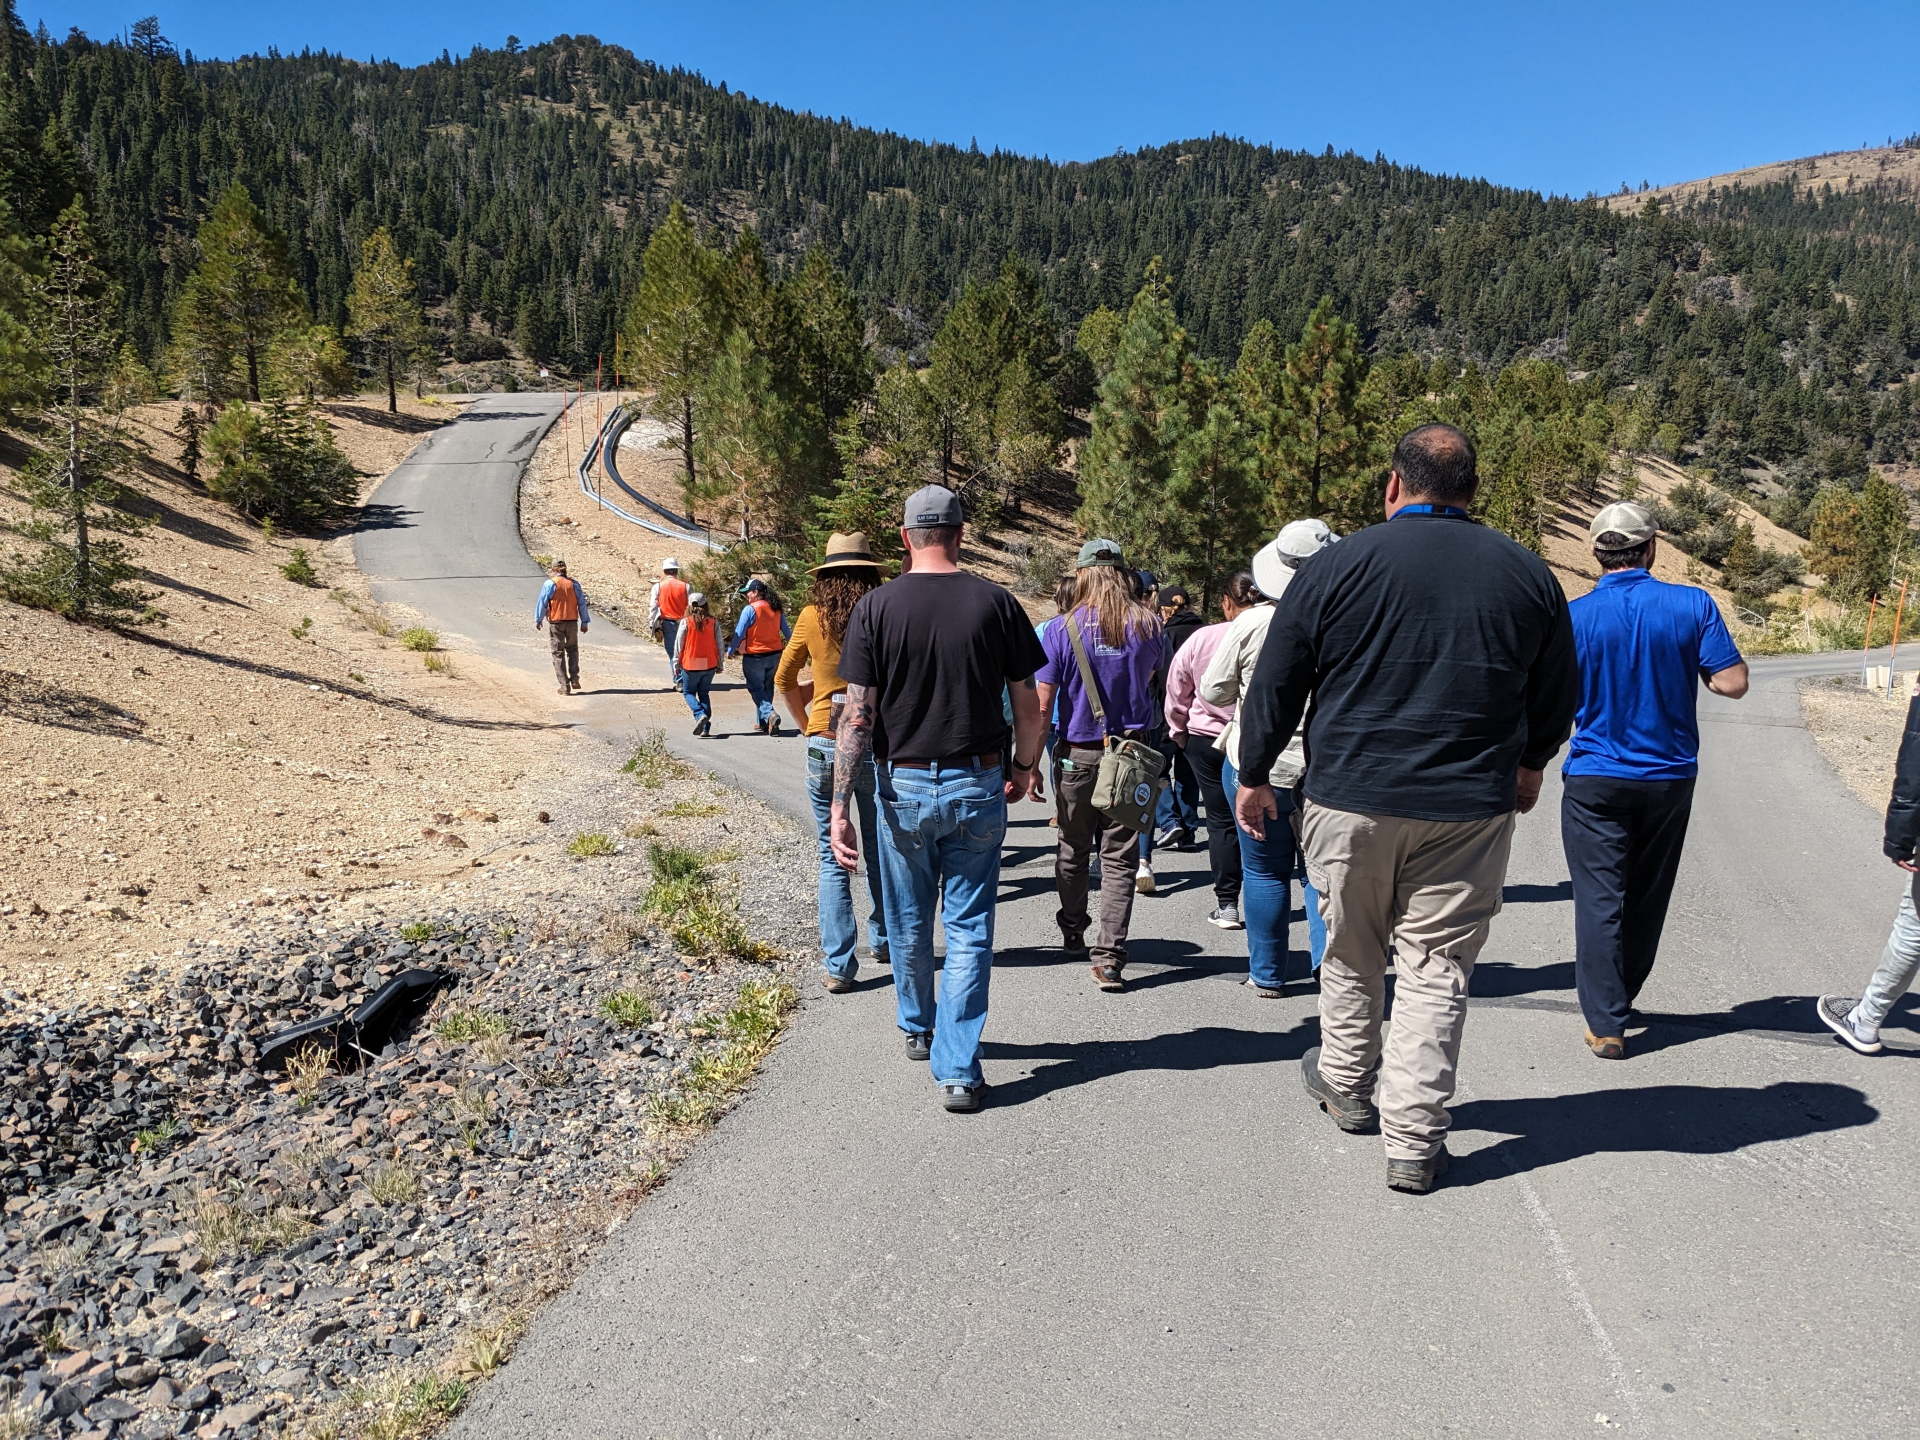
Stop 3: Overview from the Top of Pond 2N

This stop included
additional ponds and
an overhead view of
the high-density
sludge treatment
plant.

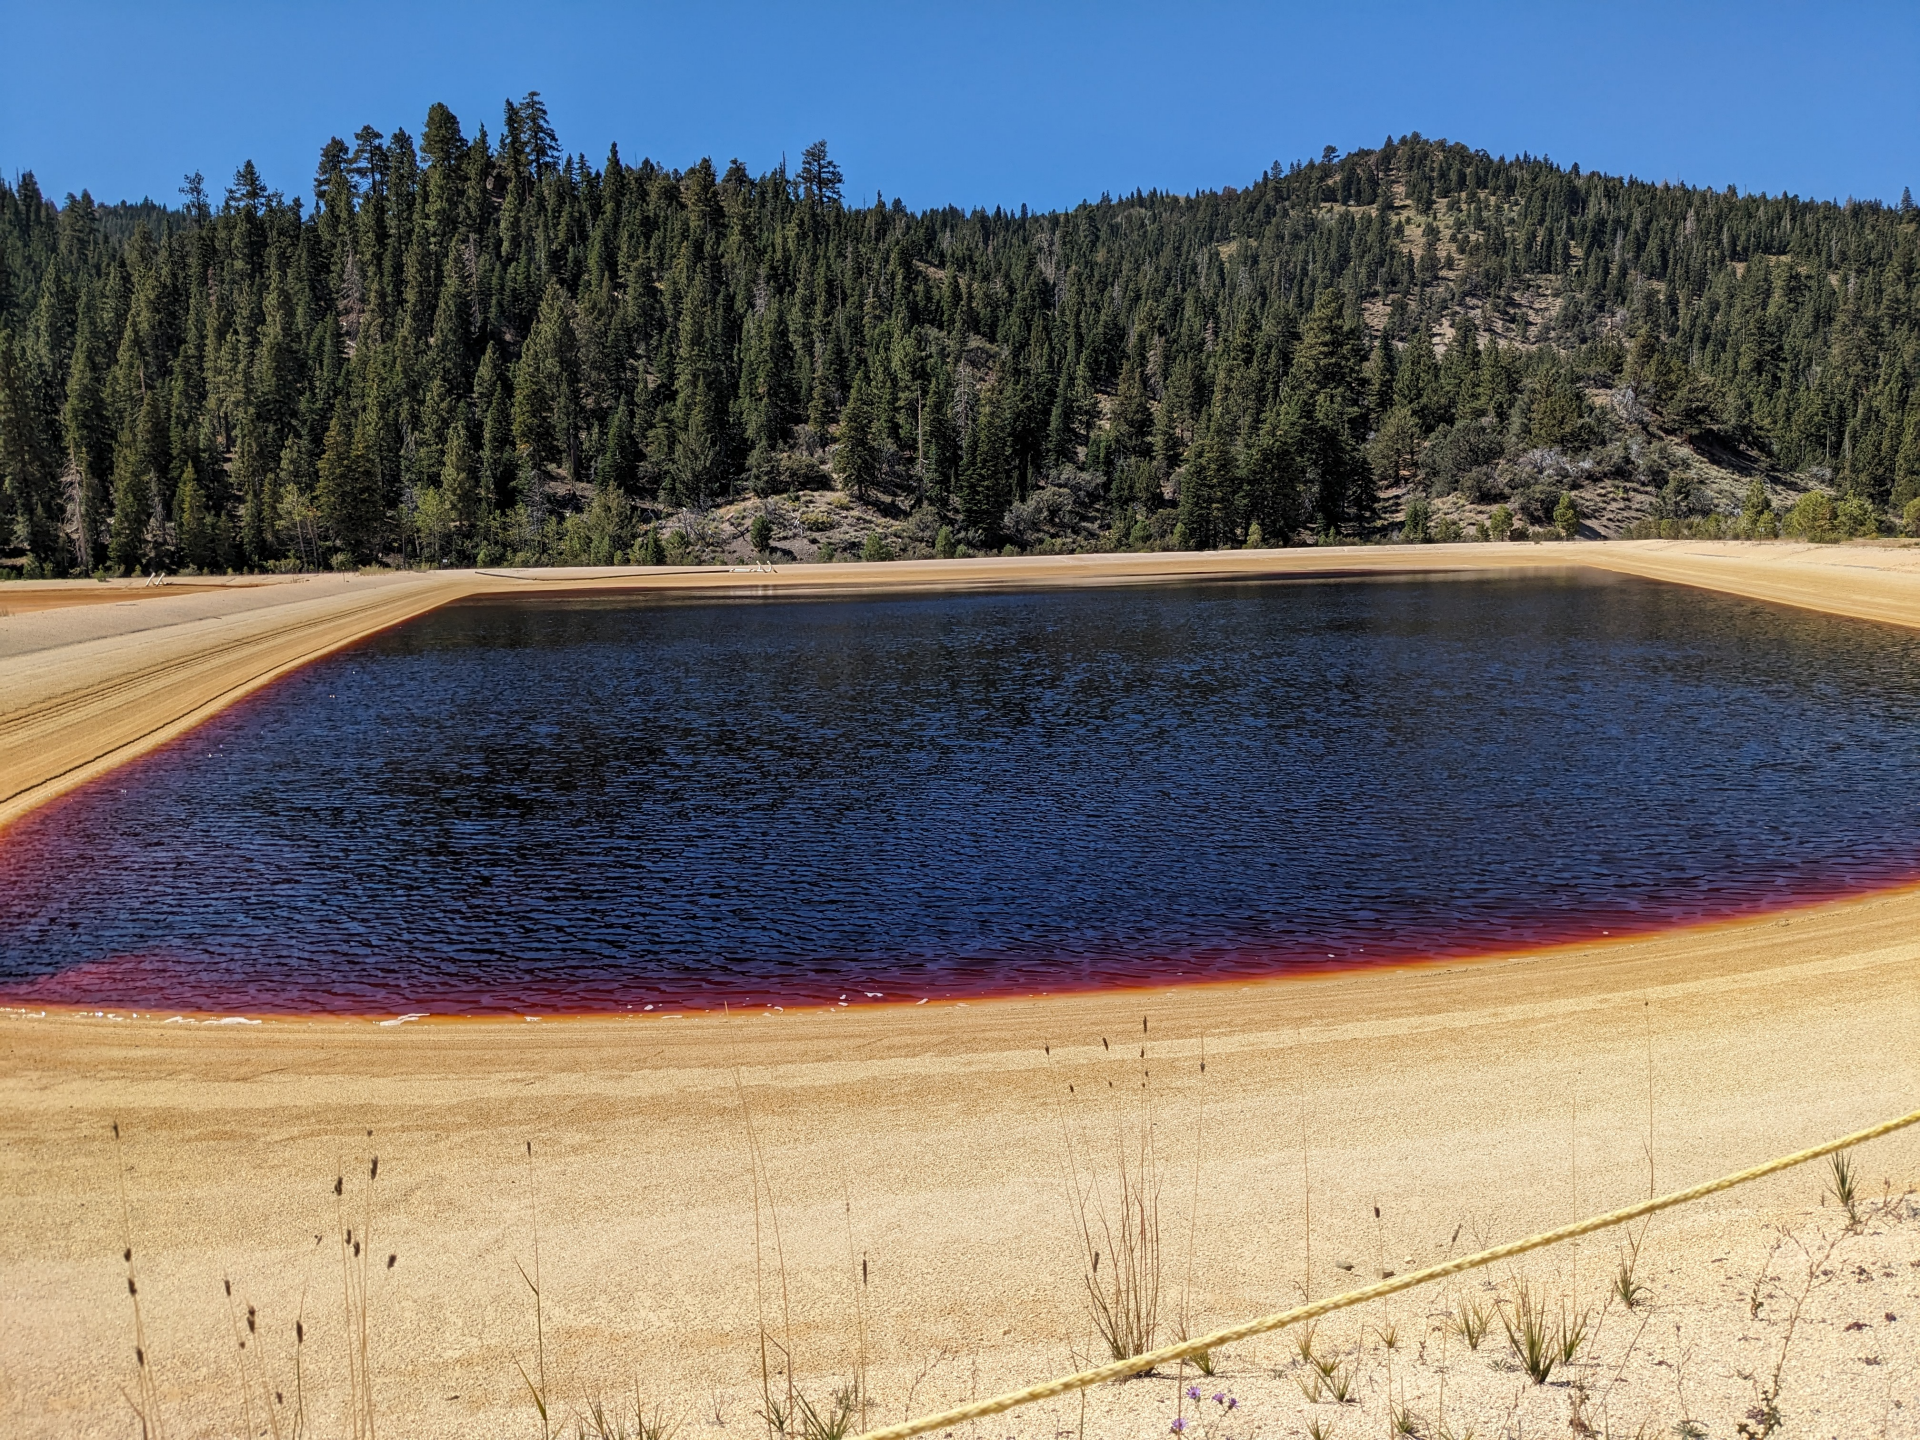
Pond 2 South: part of
the pond water
treatment system

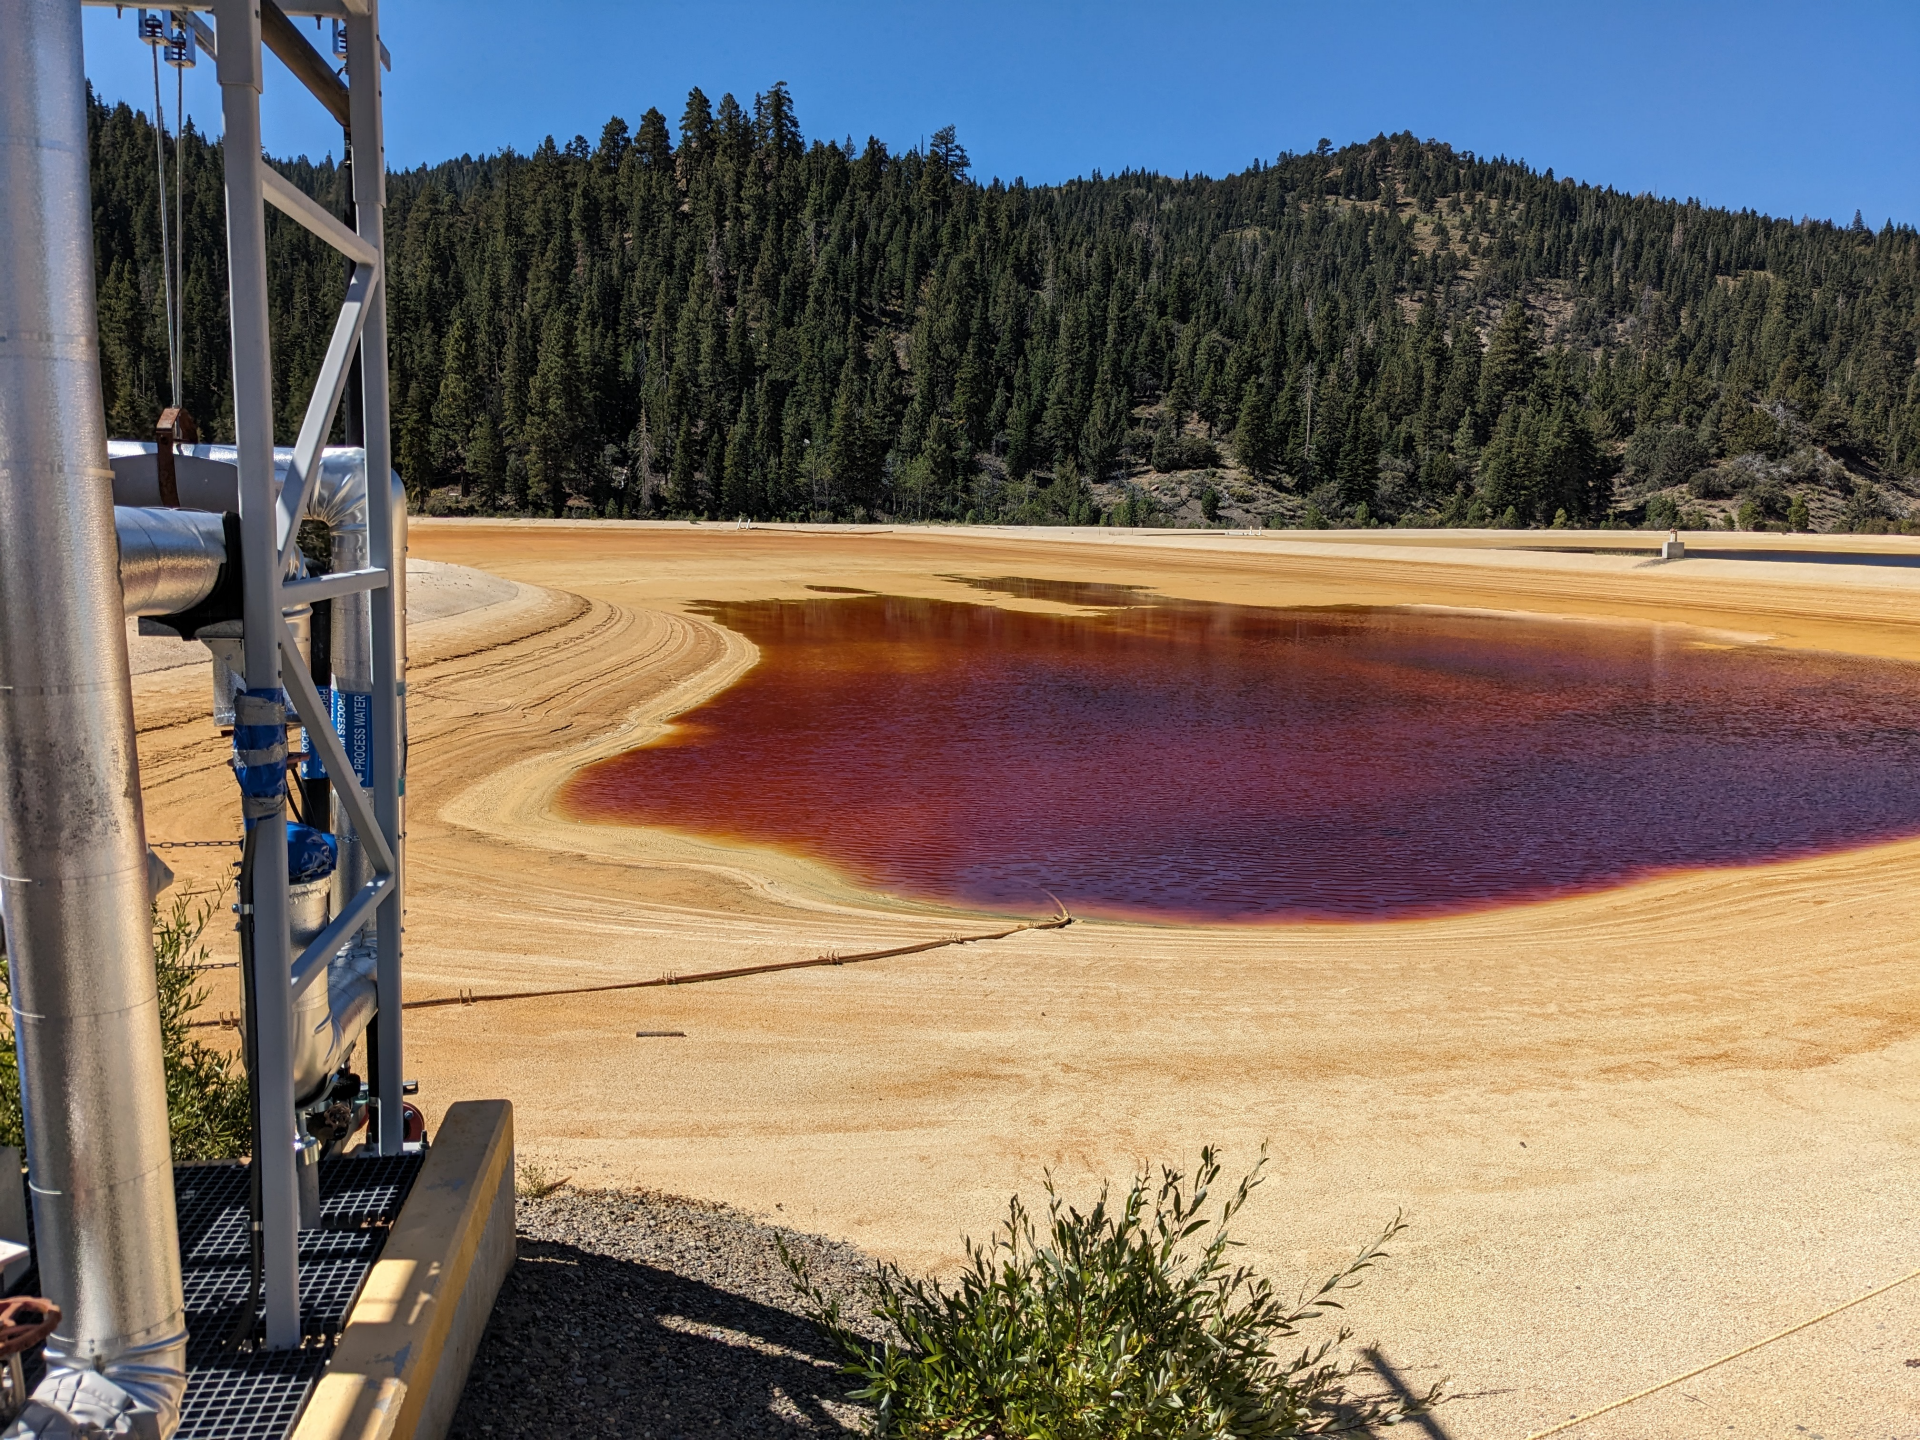
Pond 2 North: part of
the pond water
treatment system
