Washoe Tribe of Nevada and California
2023 Leviathan Mine Superfund Site Tour

History

3 Treatment Processes

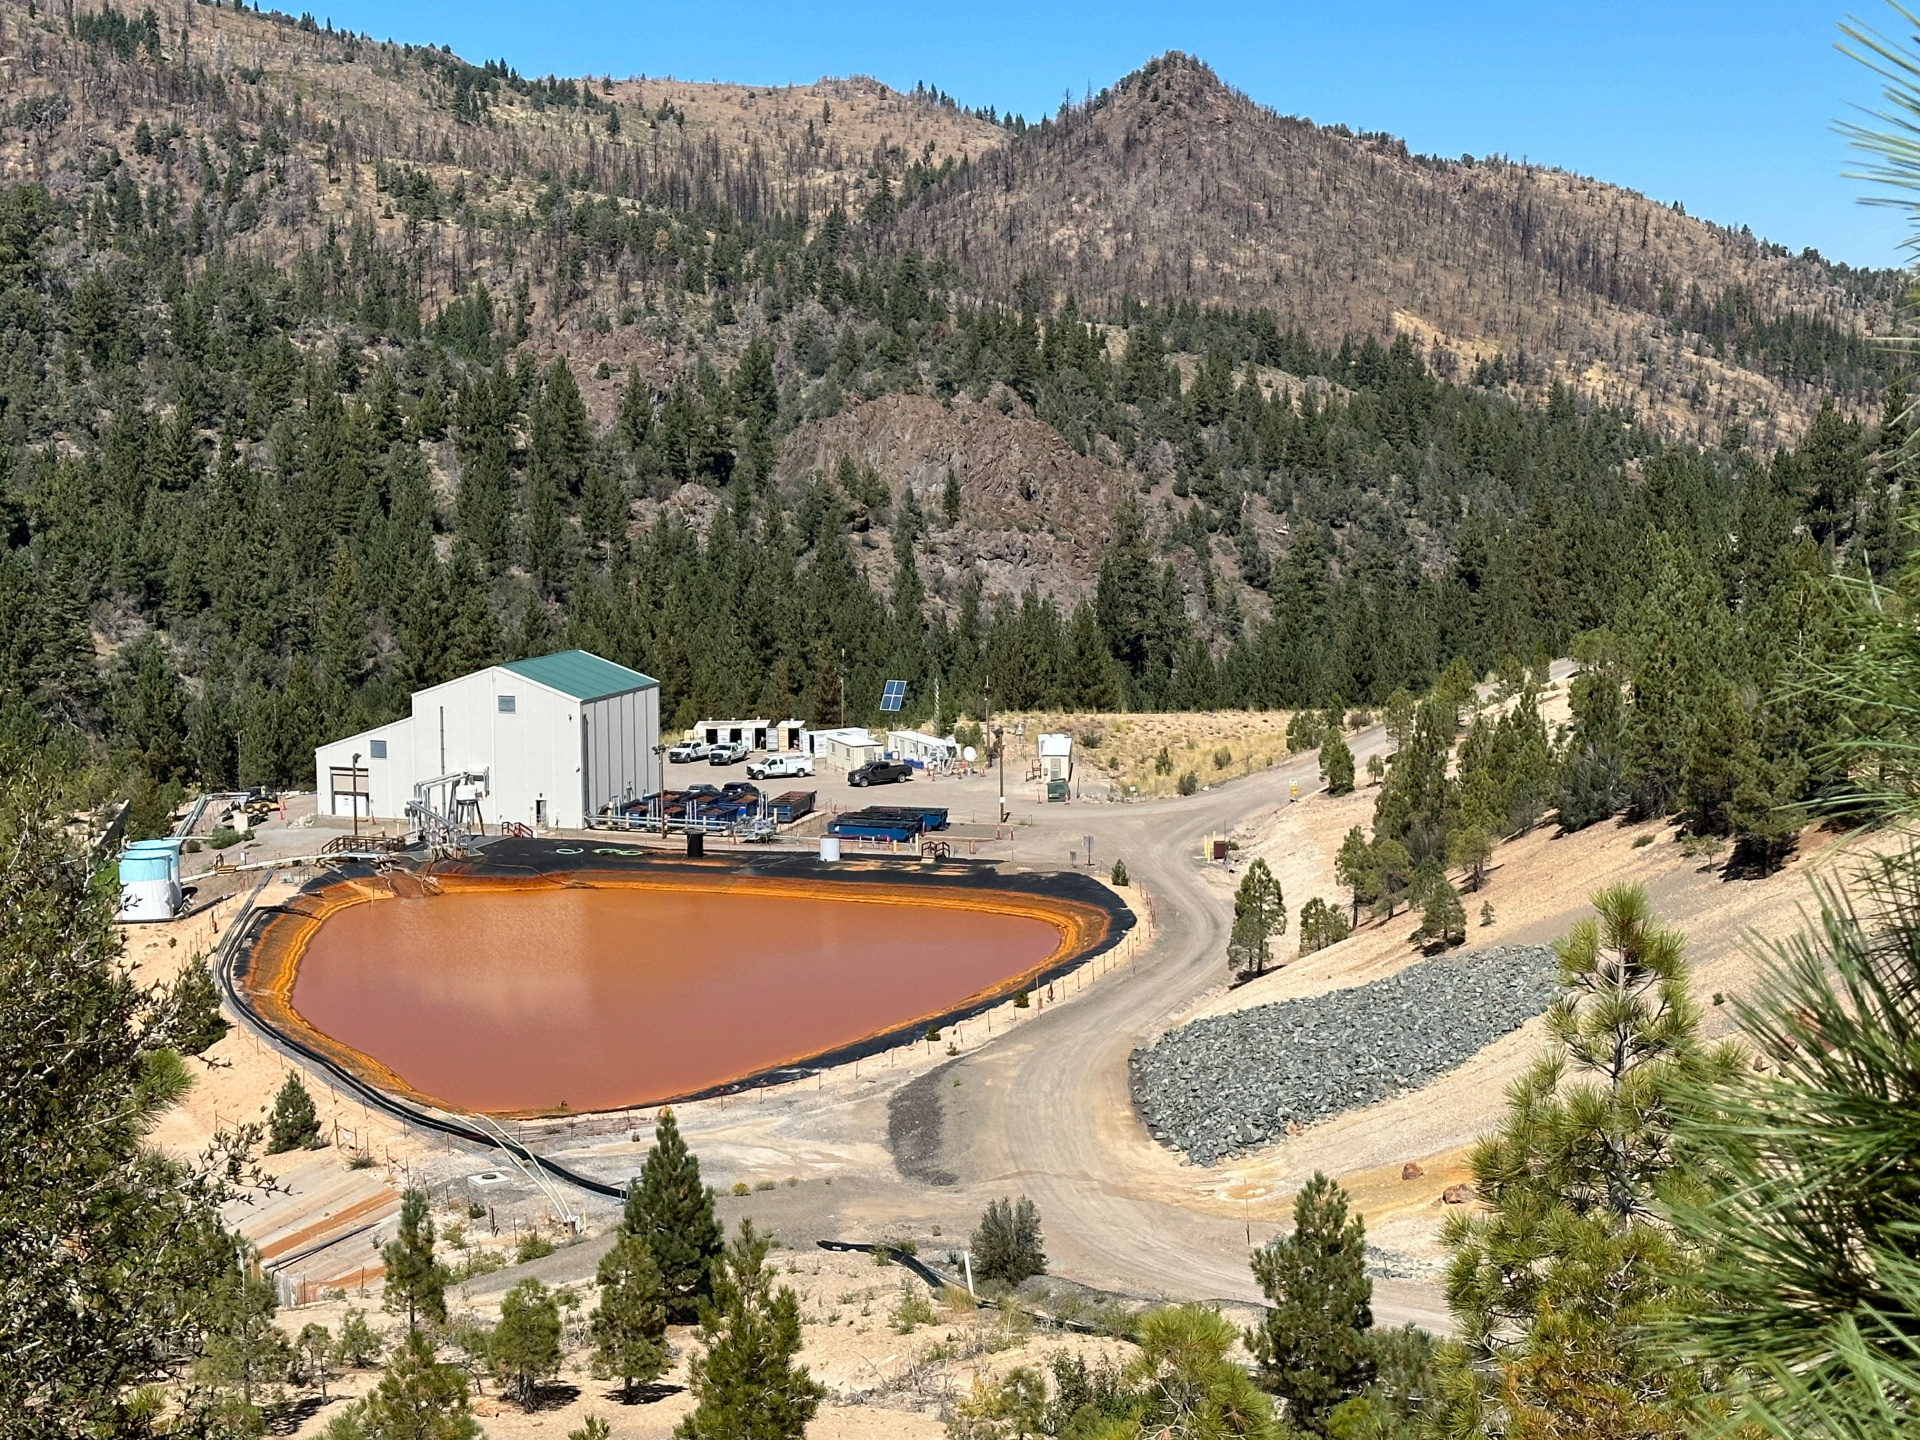
An overhead view of Pond 4 and the high-density sludge treatment plant. To the right of the pond, you can see a stretch of grey gravel reinforcing the hill where a landslide previously occurred.

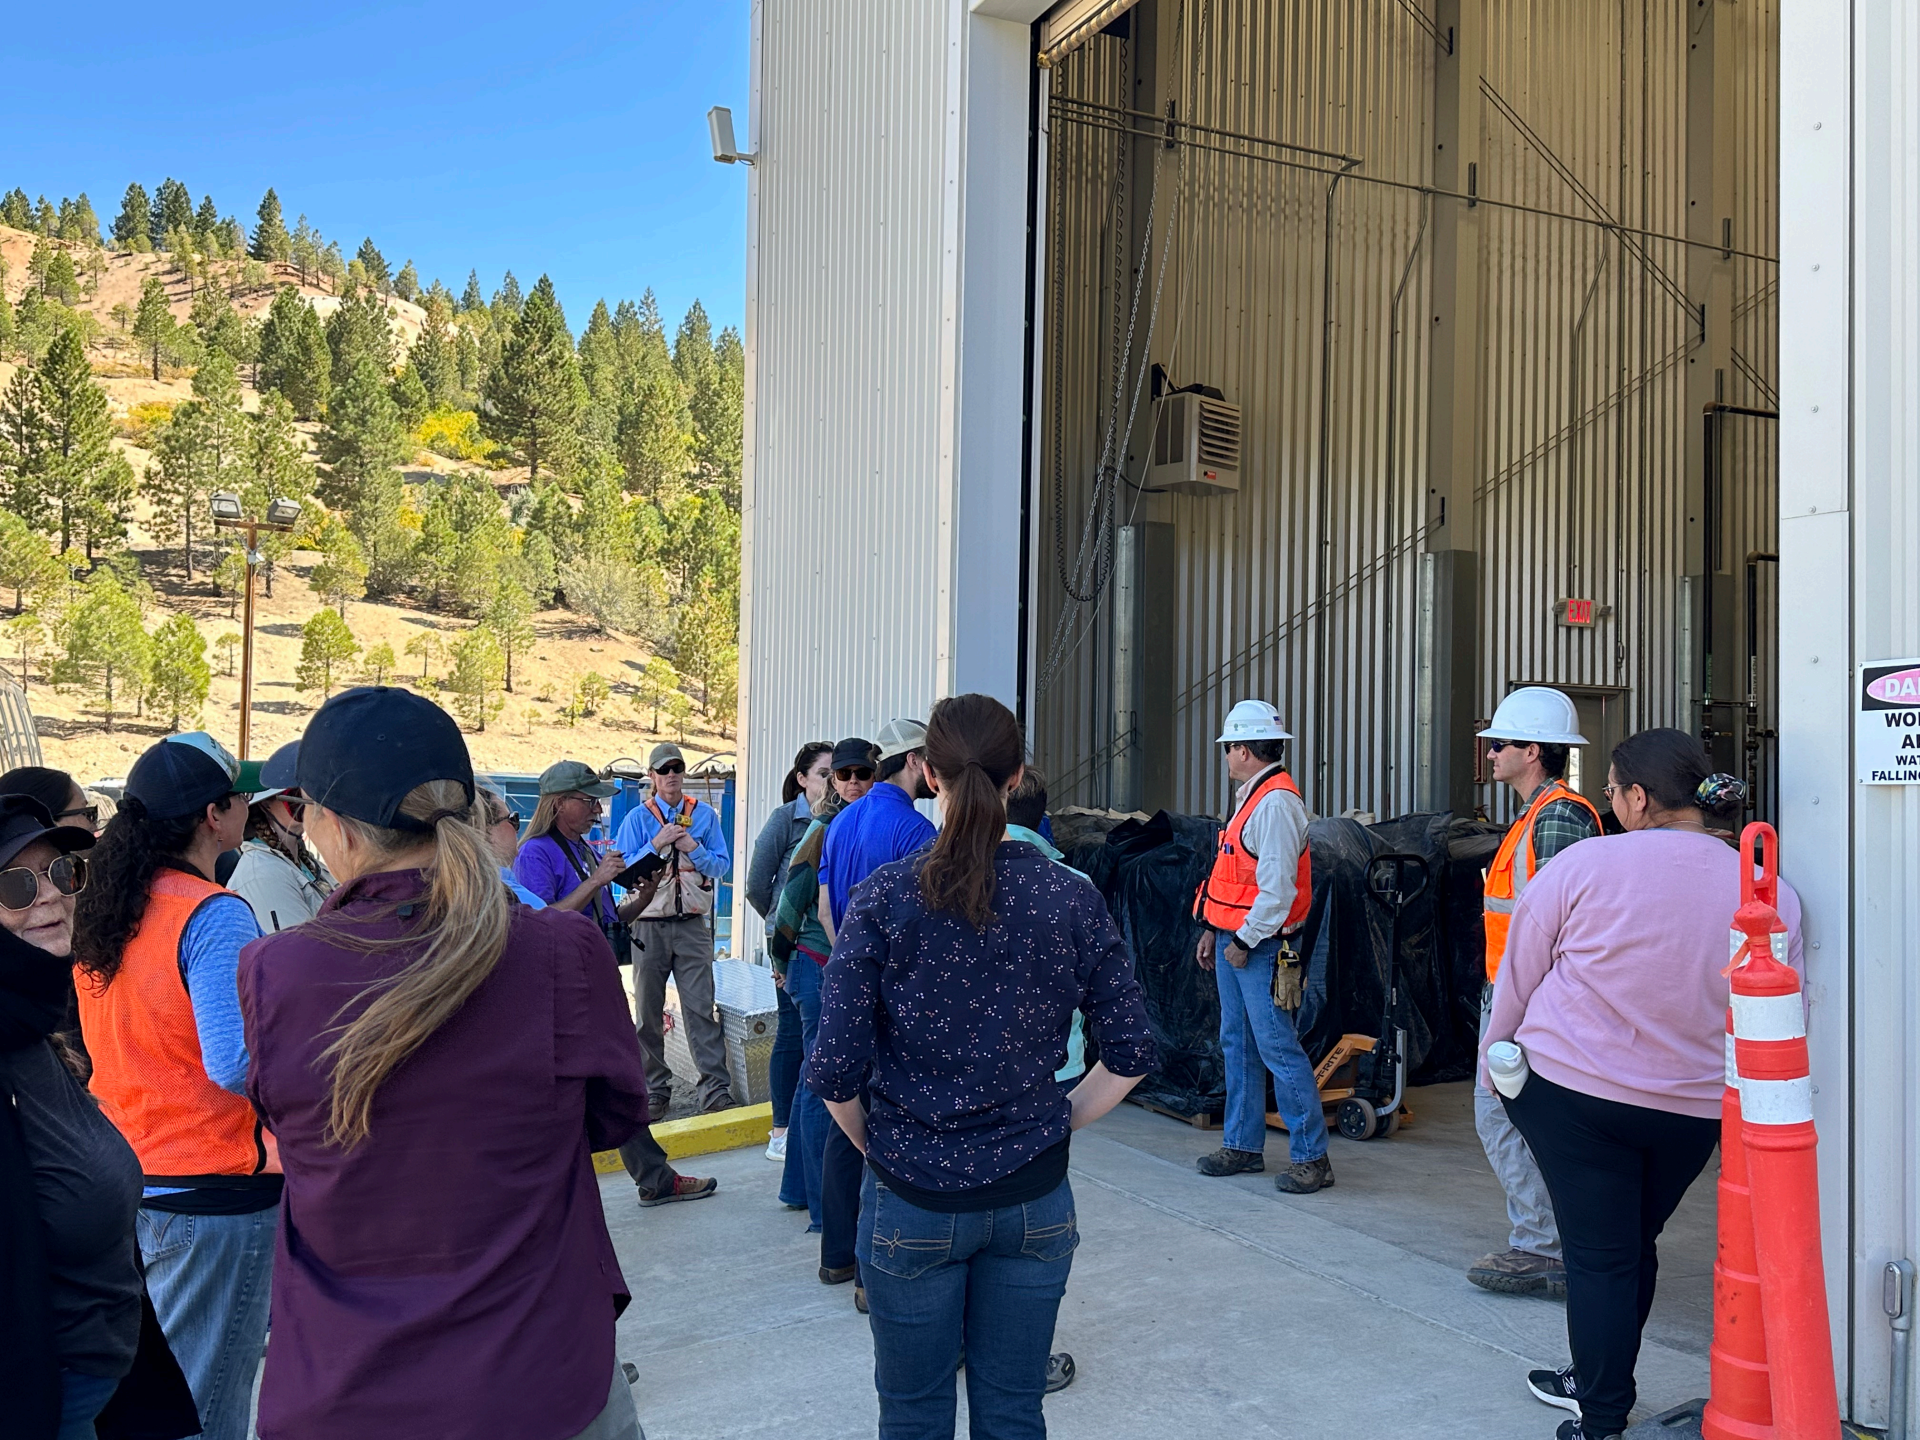
Stop 4: The High-Density Sludge Treatment Plant

The recommended treatment speed of the plant is 100 gallons per minute (GPM). During drier years, this might mean that the plant must pause until enough water has been collected to resume treatment. Alternately, during high precipitation years, the plant may struggle to keep up. In 2023 there was so much rain and snow that plant managers received approval from EPA to test equipment at speeds as high as 150 GPM.

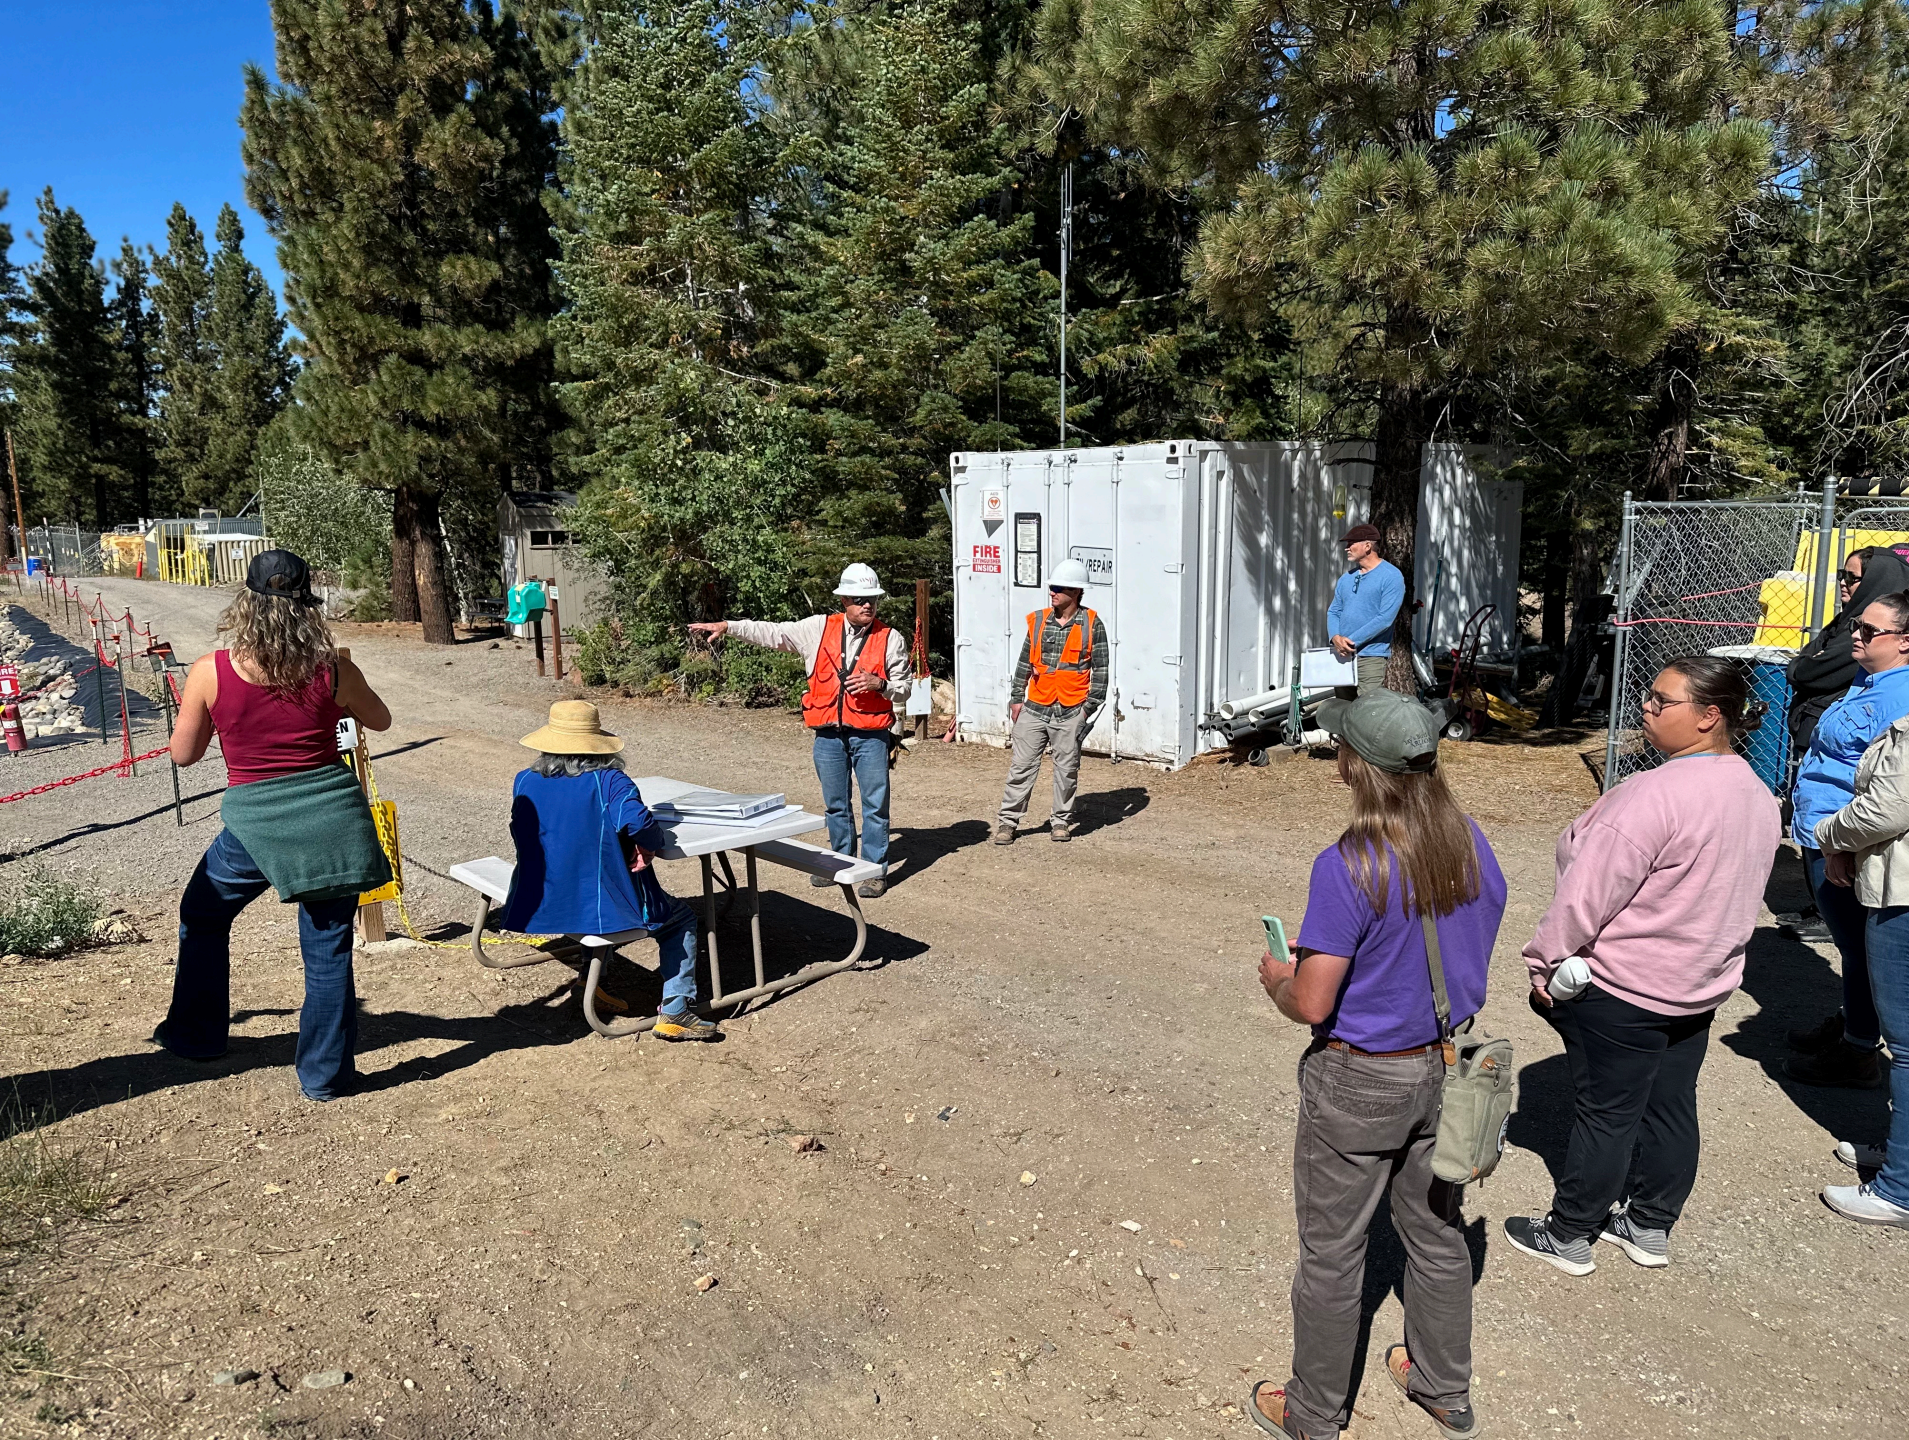
Stop 5: Aspen Seep Bioreactor

The bioreactor at the site relies on sulfate-reducing microbial organisms, such as *Desulfovibrio* sp., to reduce sulfate to sulfide.

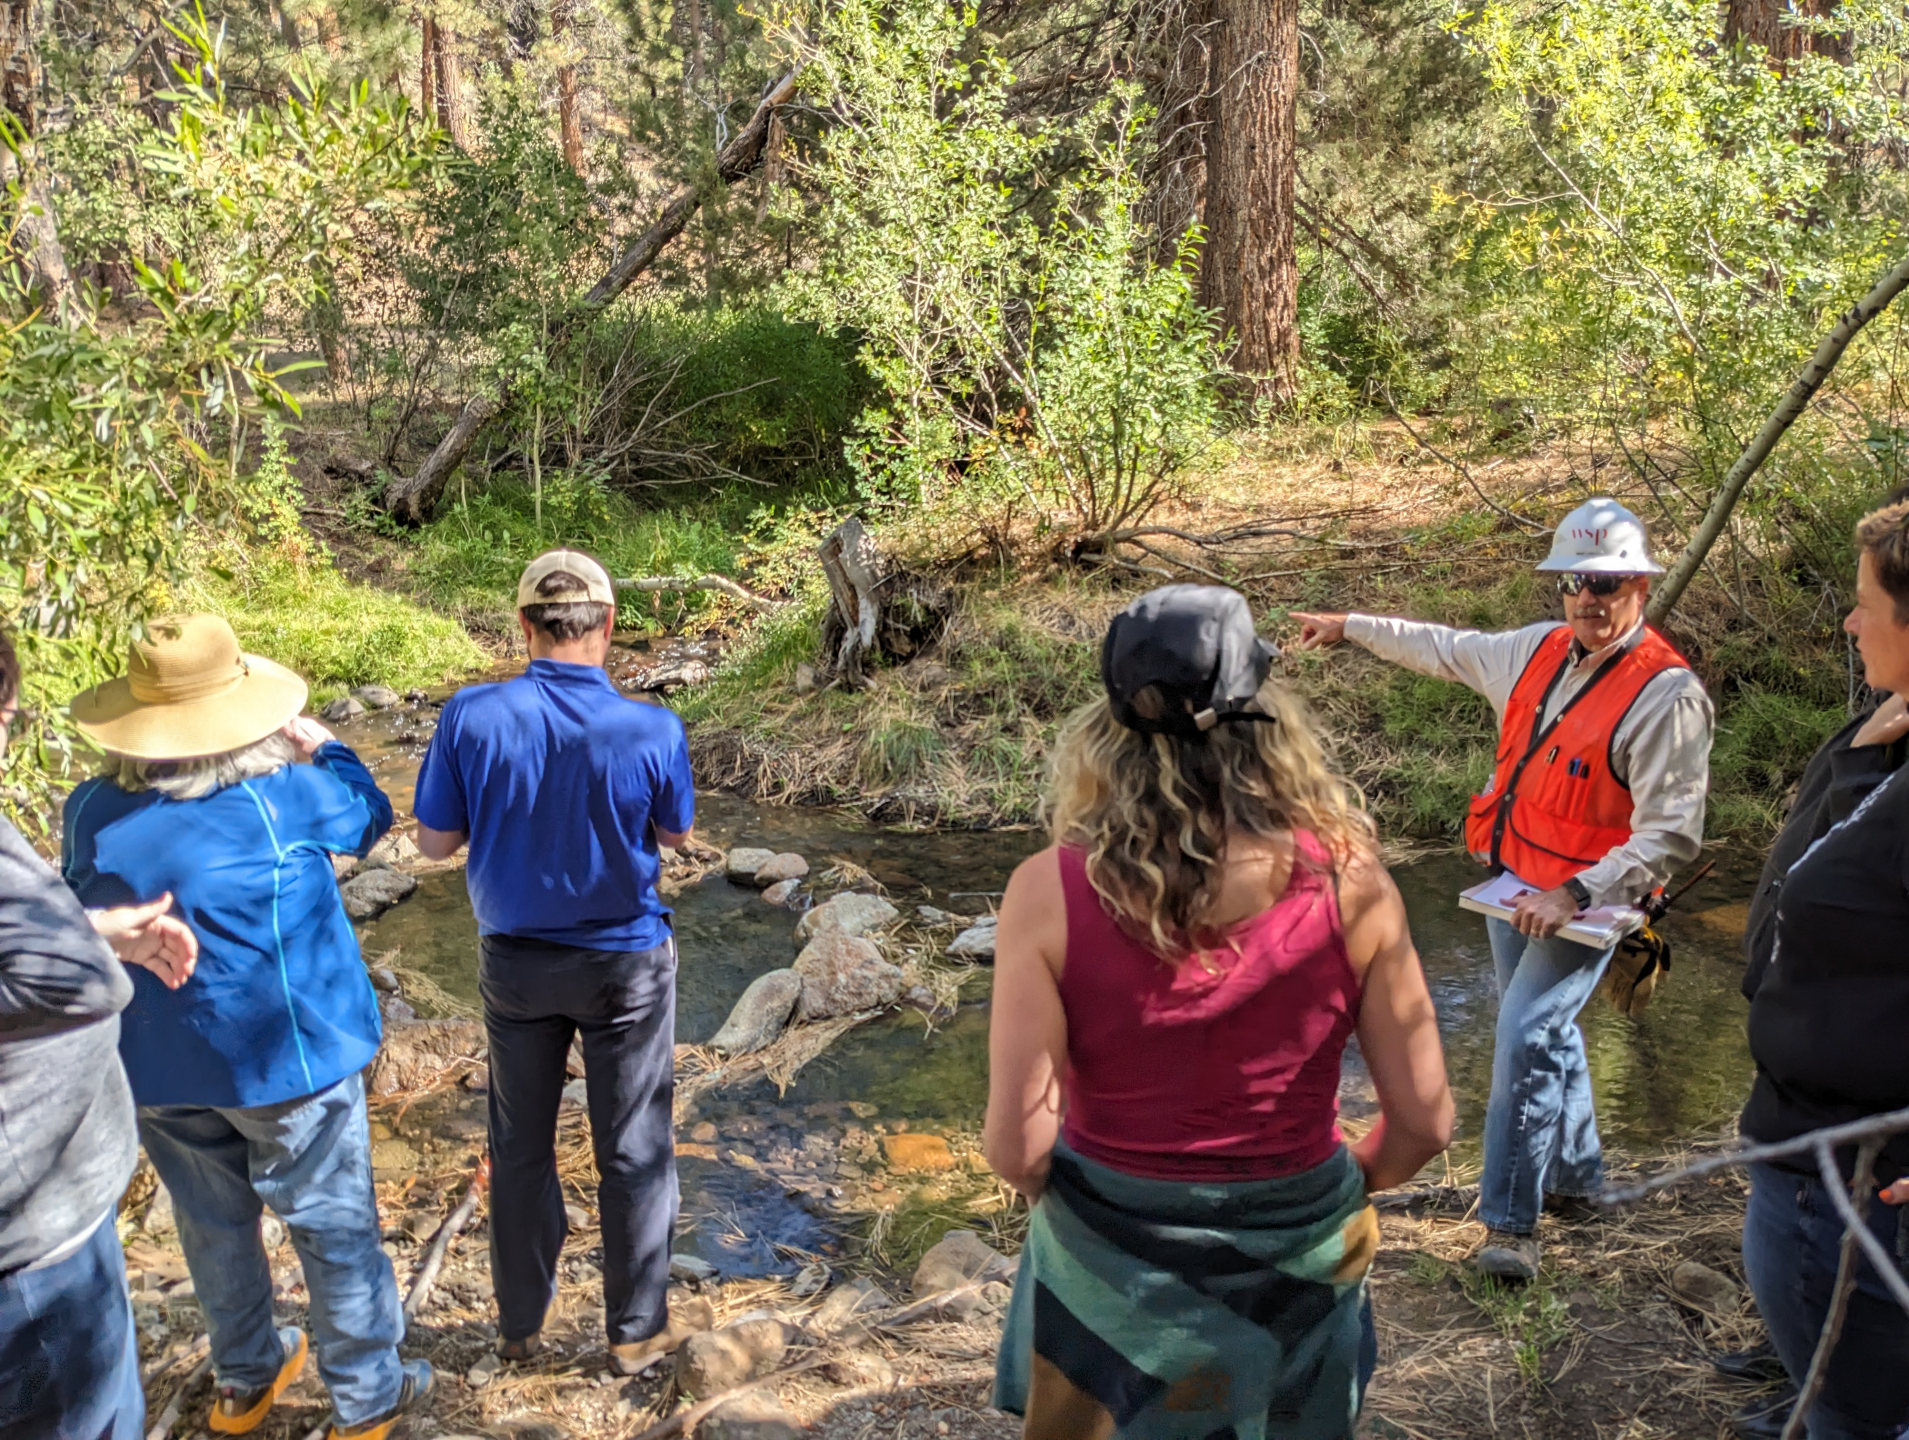
Stop 6: Confluence of Leviathan Creek and Aspen Creek

Mark Lombardi, Geologist for WSP, discusses the benthic microinvertebrate research that has occurred for almost 30 years. Data indicating the health of Leviathan Creek correlate with when water treatment operations are running at the Superfund site.

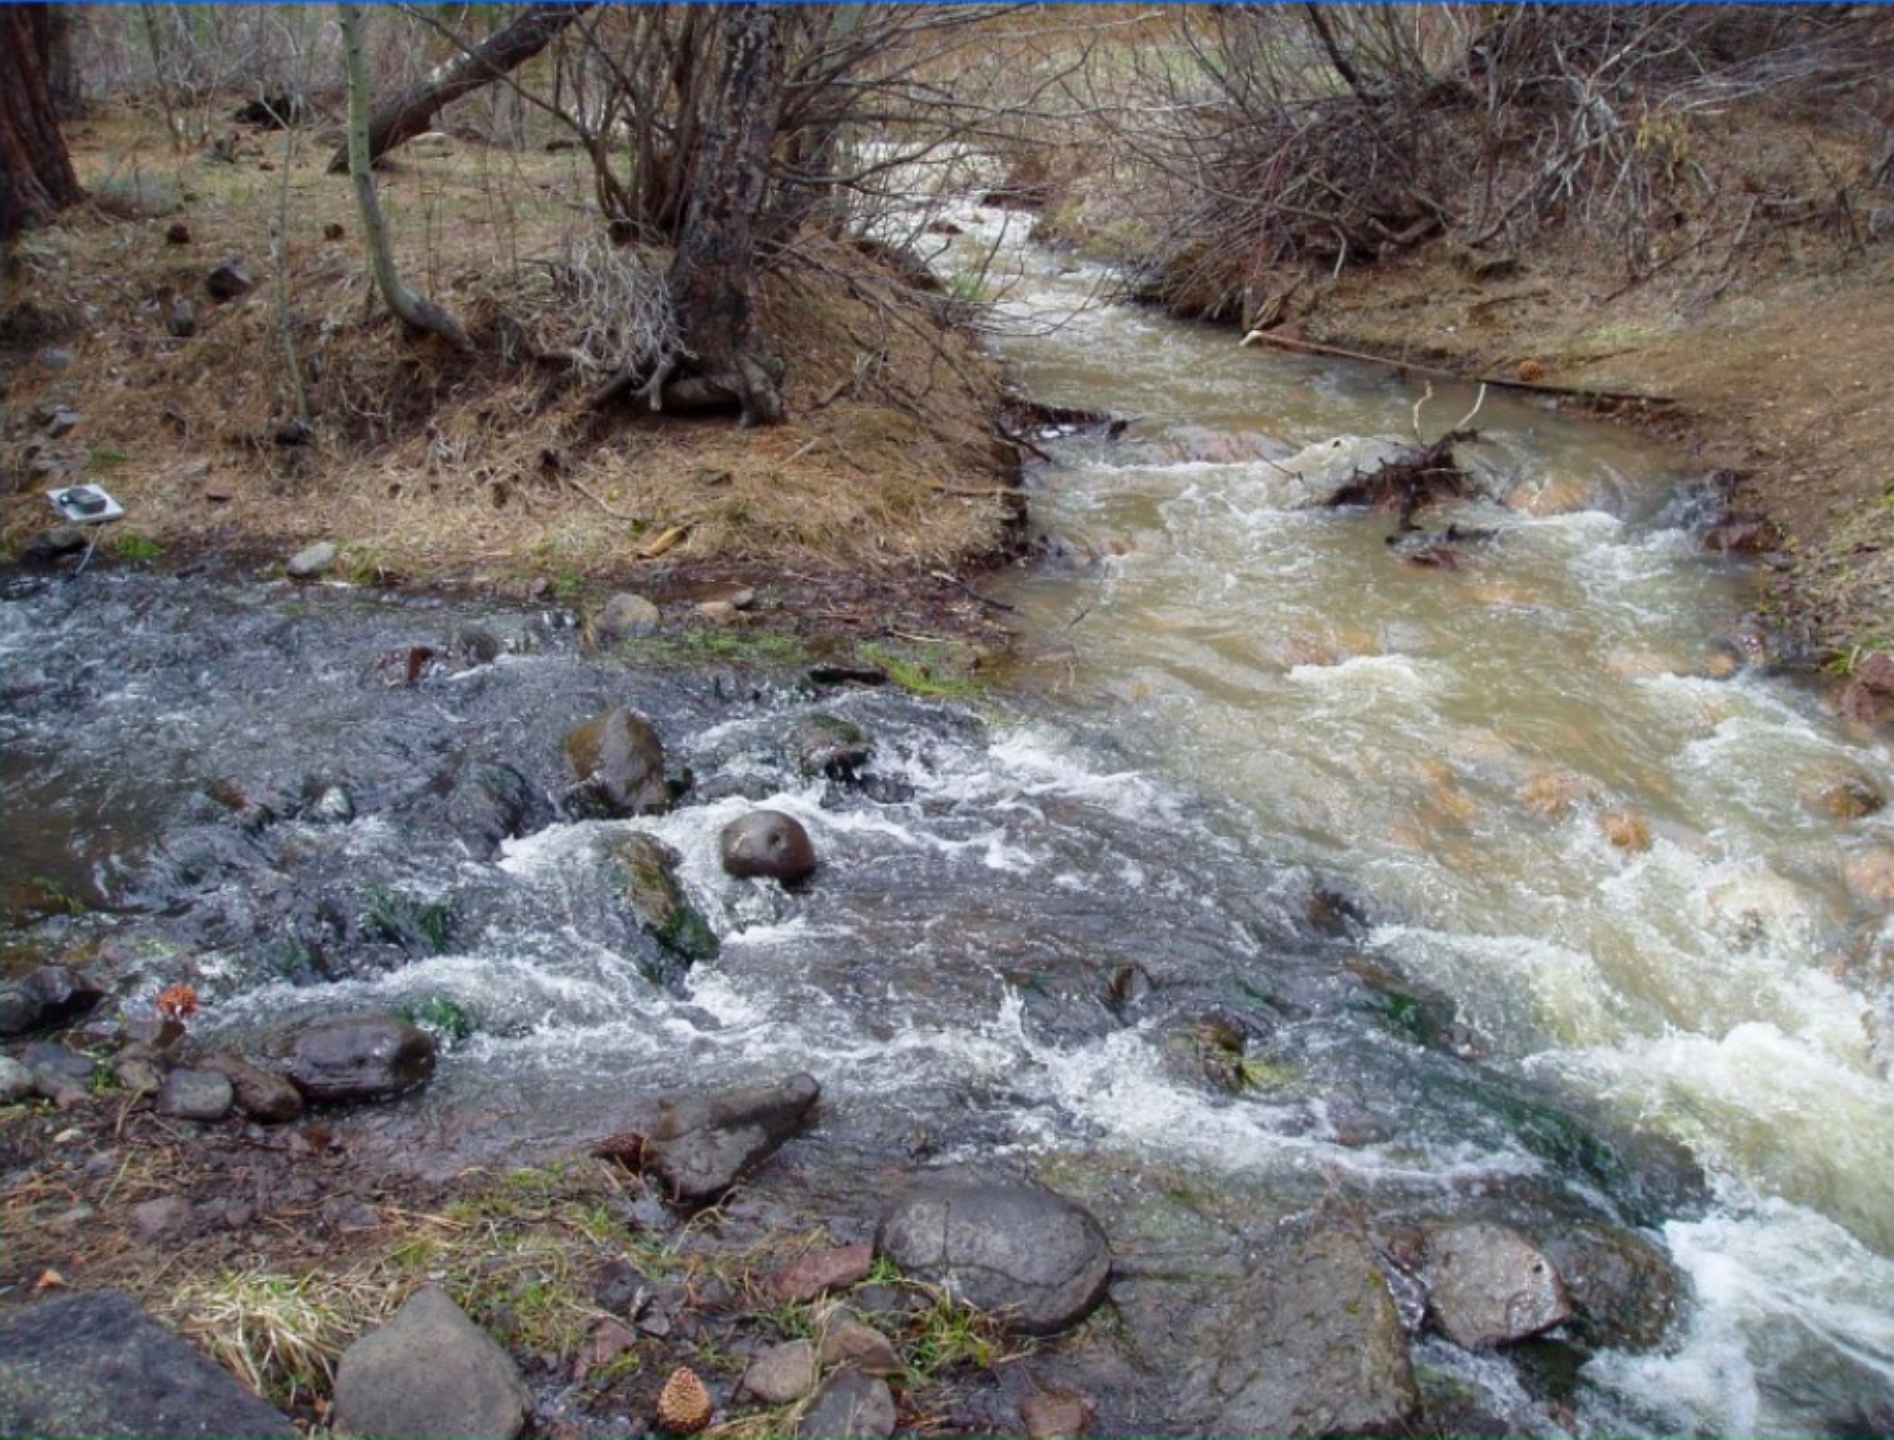
This photo from the 1990s shows the confluence of Leviathan and Mountaineer Creeks (a little further down the creek from the previous slide) prior to the development of the water treatment facilities.
